Subject: WIND NOISE AT REAR DOOR QUARTER GLASS	Bulletin No.: 09-024/18
	Last Issued: 05/10/2018

2014-2016 Mazda6

2017 Mazda6 vehicles with VINs lower than JM1GJ*****153693 (produced before Dec. 5, 2017)

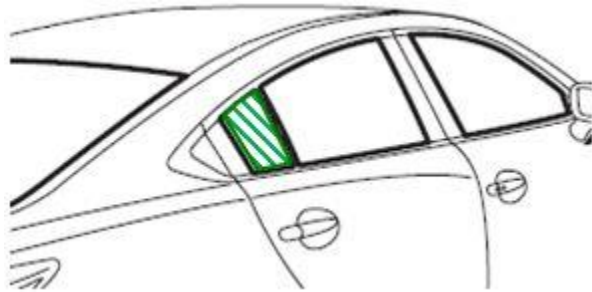
Some vehicles may exhibit wind noise at rear door quarter glass when driven at high speeds. This is caused by air leakage from the gap between rear sash molding, rear door glass run channel, rear door glass guide and rear door quarter glass guide.

To eliminate this concern, the following items have been added or changed:

- A rubber seal on rear door quarter glass guide has been extended.
- A rubber seal has been added to rear door glass guide.
- The shape of rear door glass run channel has been changed.
