Subject: MAZDA CONNECT TOUCH SCREEN DOES NOT WORK OR OPERATES BY ITSELF (GHOST TOUCH)	Bulletin No.: 09-026/18
	Last Issued: 05/14/2018

2014-2016 Mazda3 (Japan and Mexico built)

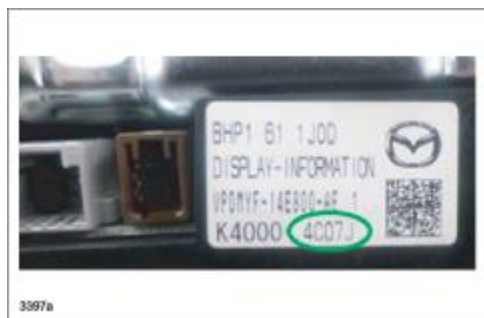
1. Verify customer concern.
2. Remove the center display according to the instructions on MGSS online (CENTER DISPLAY REMOVAL /INSTALLATION).
3. Look at the label at the bottom of the center display and check the first **four** digits of the lot number.

- If the lot number starts with **3,4,5 or 1505-1611**, go to the next step.
- If the lot number starts with **1612 or higher, this TSB does not apply**. Follow the instructions on MGSS for further diagnosis.

4. Replace the center display with a new one.
5. Verify repair.
