Service Alert

Subject: LACK OF POWER UNDER HEAVY LOAD, NO WARNING LIGHTS OR DTCs	Service Alert No.: SA-024/18
	Last Issued: 05/03/2018

2016-2018 CX-3	2016-2018 MX-5
2013-2018 CX-5	2013-2018 Mazda3
2016-2018 CX-9	2014-2018 Mazda6

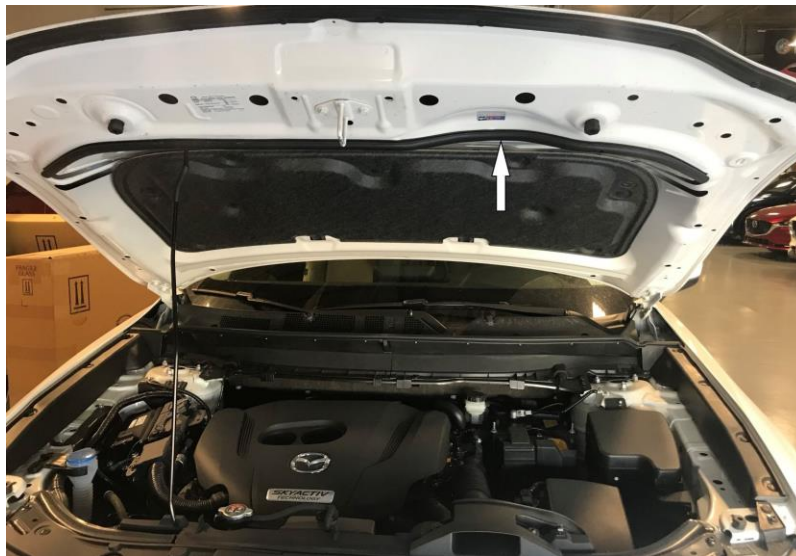
(Hood Weatherstrip Location Shown Below, Correctly installed)

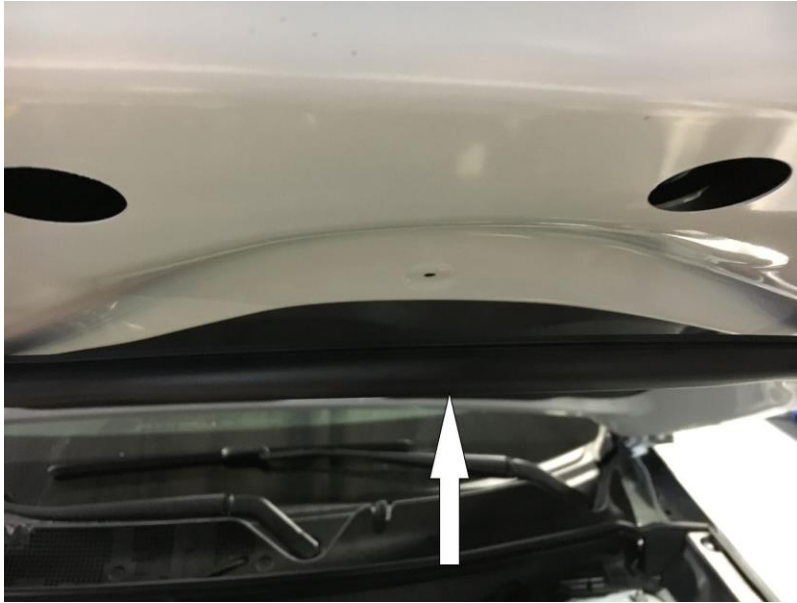
Some customers may complain of a lack of power under heavy load without any warning lights or DTCs. This concern may be due to a loose or detached hood weatherstrip, which can cause a blockage or restriction in the air intake system.

(Hood Weatherstrip Shown Below, Loose / Detached From Hood)

To correct this concern, reattach the weatherstrip or replace it with a new one if it is damaged.
