Service Alert

Subject: 360° VIEW MONITOR SYSTEM AIMING PROCEDURE IS UNSUCCESSFUL	Service Alert No.: SA-025/18
	Last Issued: 05/04/2018

2018 Mazda6 equipped with 360° View Monitor System

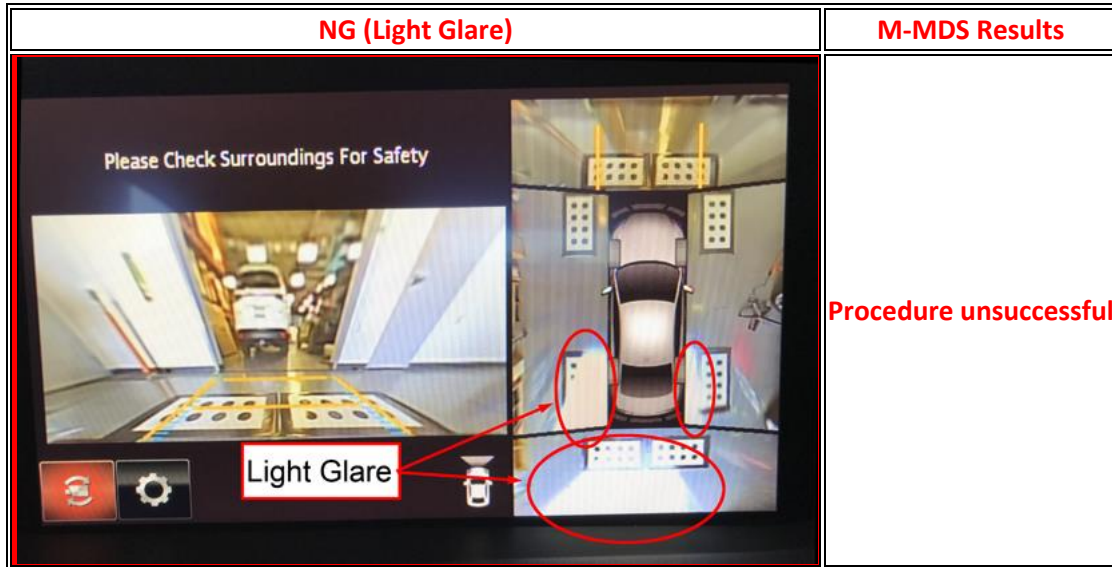
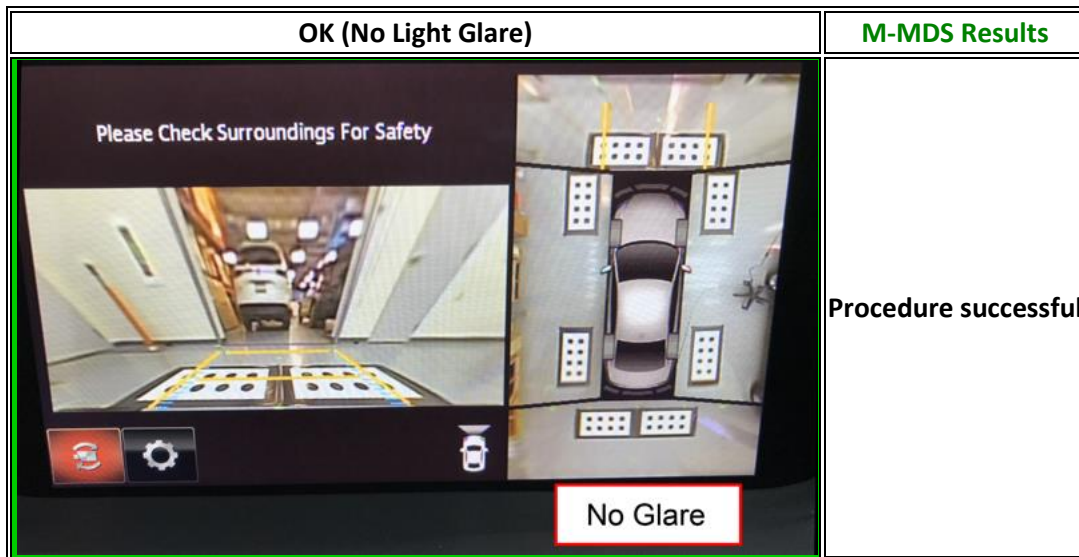
This error message may be caused by light glare.
 Light glare can be identified by using the center display as shown below:

If light glare is found using the center display, remove the light glare.
 After light glare is removed, perform the aiming procedure again. M-MDS should now show "Procedure successful".
