Service Alert

Subject: ENGINE OIL DILUTED WITH FUEL CAUSES P0172:00	Service Alert No.: SA-026/18
	Last Issued: 05/08/2018

2014-2018 Mazda3	2016-2019 CX-3	2016-2018 CX-9
2014-2018 Mazda6	2013-2018 CX-5	2016-2018 MX-5

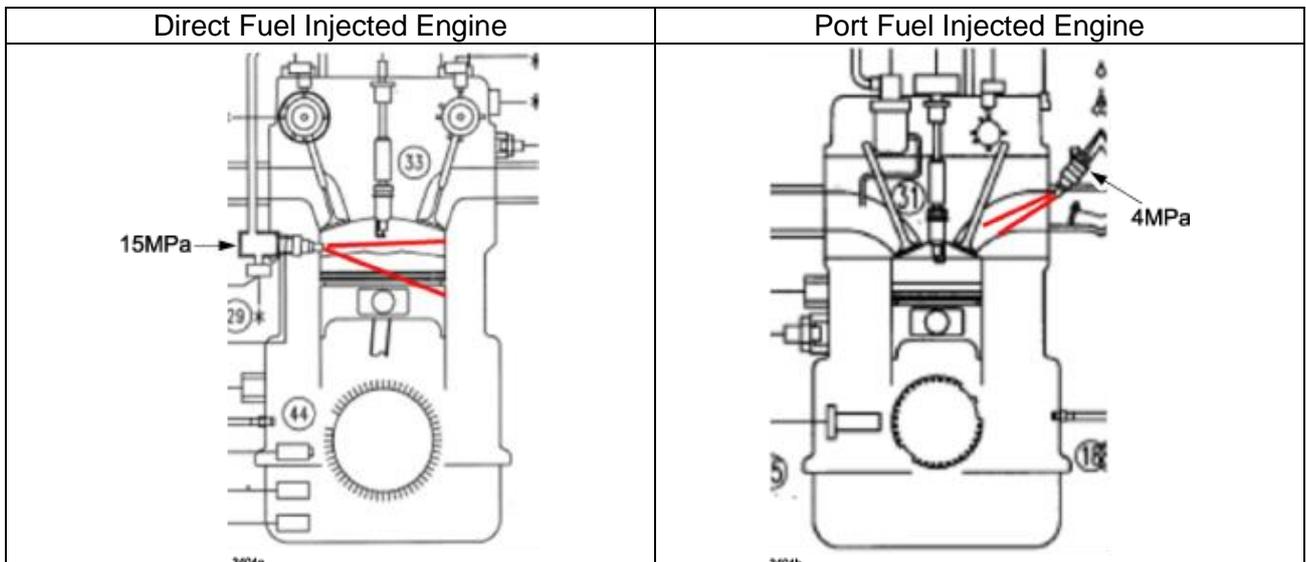
Newer direct fuel injected gasoline engines are designed such that high-pressurized fuel is injected directly into the combustion chamber, which may cause the fuel to adhere to the cylinder wall. The fuel is then scraped by the piston ring and flows down into the crankcase where it mixes with the engine oil, causing the engine oil to become diluted with fuel.

On an older port fuel injected gasoline engine, fuel is injected upstream of the intake valve, so it is unlikely fuel will adhere to the cylinder walls.

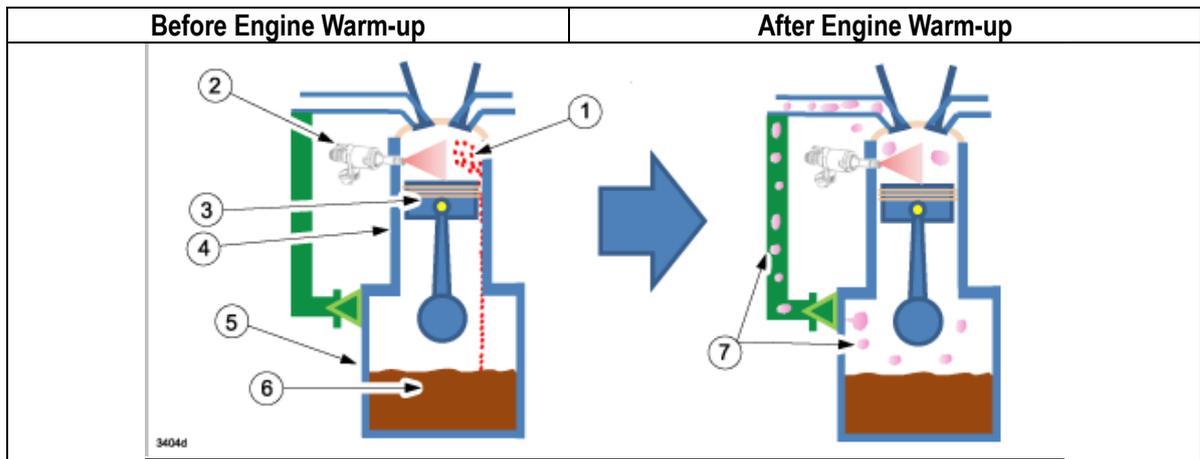
Normal Engine Operation:

When the engine is not warmed up, fuel (1) from the fuel injector (2) flows down between the piston (3) and cylinder wall (4) and enters in the oil pan (5) mixing with the engine oil (6).

After the engine is warmed up, fuel content (7) in the engine oil evaporates from normal engine operating temperatures and the evaporated fuel is sucked into the combustion chamber and burned off. The amount of fuel injected by the fuel injectors is adjusted according to the amount of fuel evaporated from the engine oil and entering the combustion chamber.

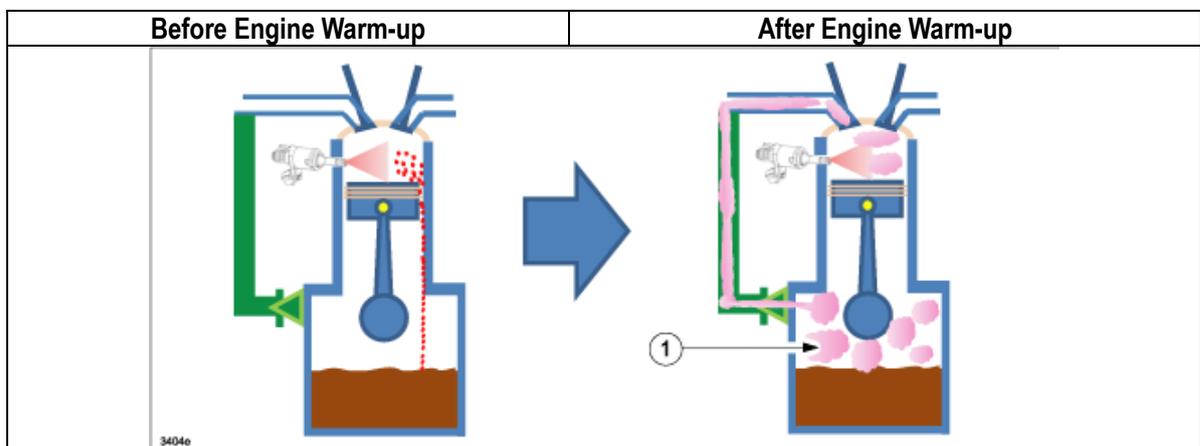
The vehicle is driven repeatedly where the engine never reaches normal operating temperature, then the vehicle is driven for a longer period of time and reaches normal operating temperature.

After the engine reaches normal operating temperature, a larger amount of fuel content (1) in the engine oil evaporates and is burned off in the combustion chamber and the amount of fuel evaporated exceeds the limit that the fuel injectors can adjust by changing the injection amount. In this case, the system turns on the Check Engine Light.

There is no problem as long as extremely short trips are not taken.

If a lot of extremely short trips are made where the engine is turned off while the low engine coolant temperature indicator light (Blue) is ON or within 5 minutes after the light turns OFF, the engine oil and filter will need to be changed more frequently. It is recommended to immediately check and replace the engine oil and filter when the Check Engine Light turns on.
