LTB01186NAS1

TECHNICAL BULLETIN

Brake Vacuum Pipe Detached From Intake Manifold

MODEL:	MODEL YEAR:	VIN:	ASSEMBLY PLANT:
Discovery Sport (LC)	2015-2017	544296-721493	Halewood
Range Rover Evoque (LV)	2014-2015	795900-999999	Halewood
Range Rover Evoque (LV)	2015-2017	000051-266123	Halewood

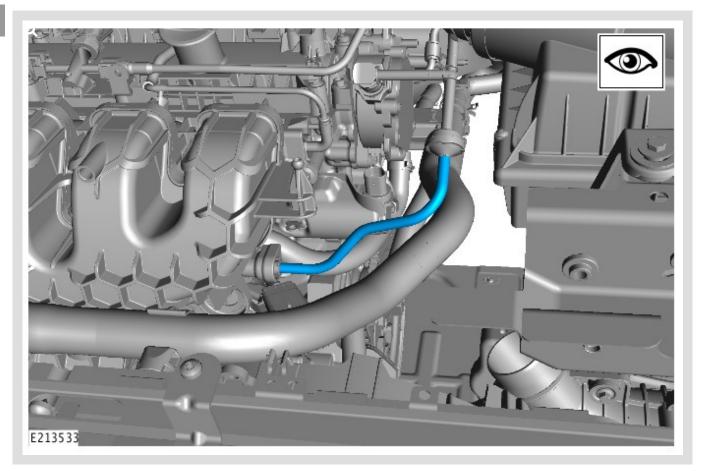
Inspect the brake booster vacuum pipe at the intake manifold.

- If the brake booster vacuum pipe is fully detached, go to Step 4.
- If the brake booster vacuum pipe is partially detached, fully detach the vacuum pipe from the intake manifold and then **go to Step 4**.
