LTB01170NAS1

# TECHNICAL BULLETIN

415-01: Information and Entertainment System

Steering Wheel Left Control Switch - Audio Volume Inoperative

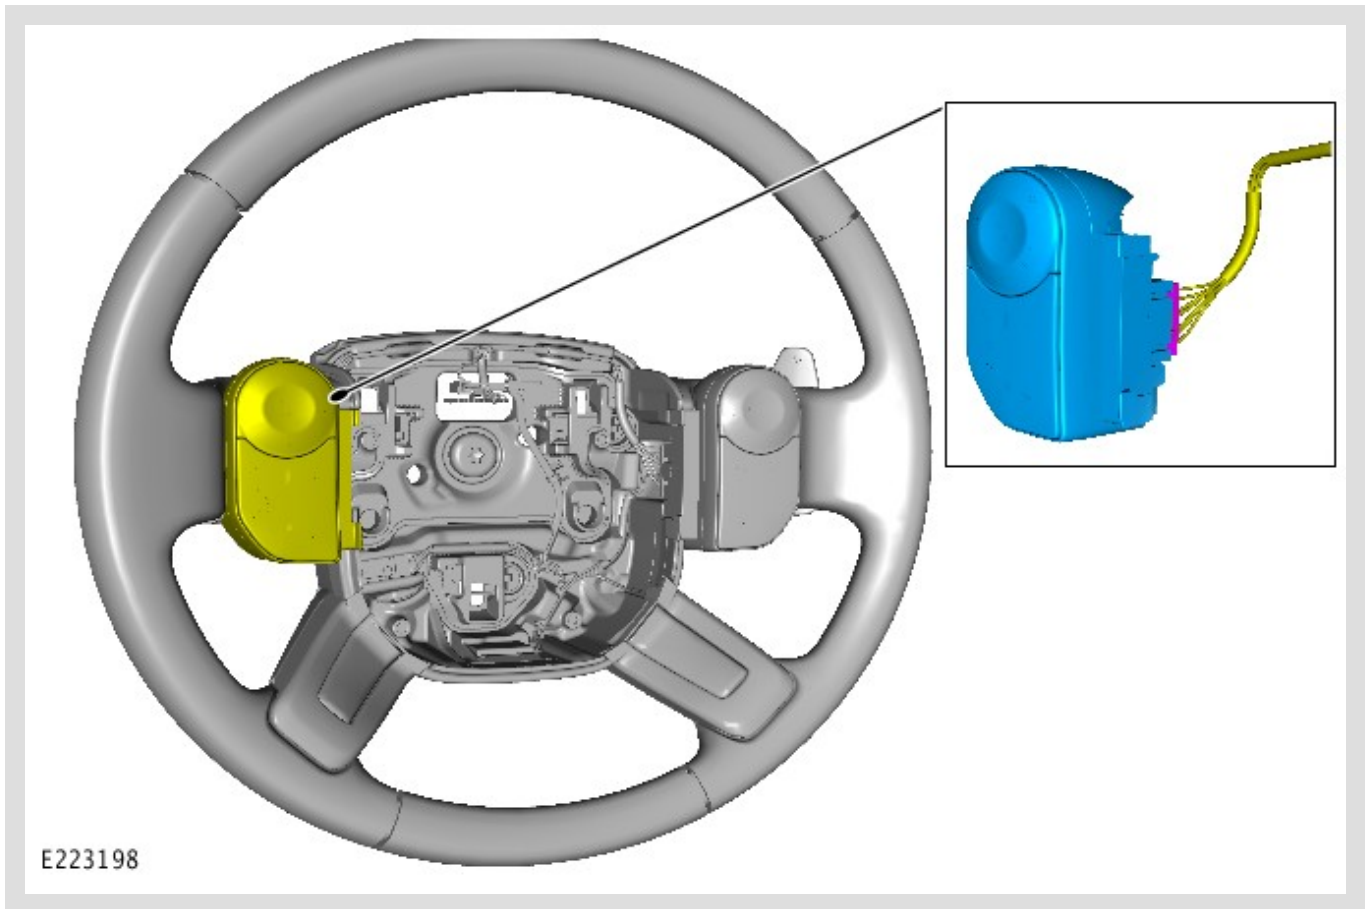
5

The steering wheel left control switch may exhibit a loss of function where the audio volume cannot be adjusted.

This may be caused by the steering wheel left control switch not being manufactured to the correct specification.

Remove and discard the steering wheel left control switch.

Reverse Steps 1-5 to install a new steering wheel left control switch.
