LTB01176NAS1

TECHNICAL BULLETIN

501-00: Body System

Water Ingress Through The Upper Area Of The A-Pillar

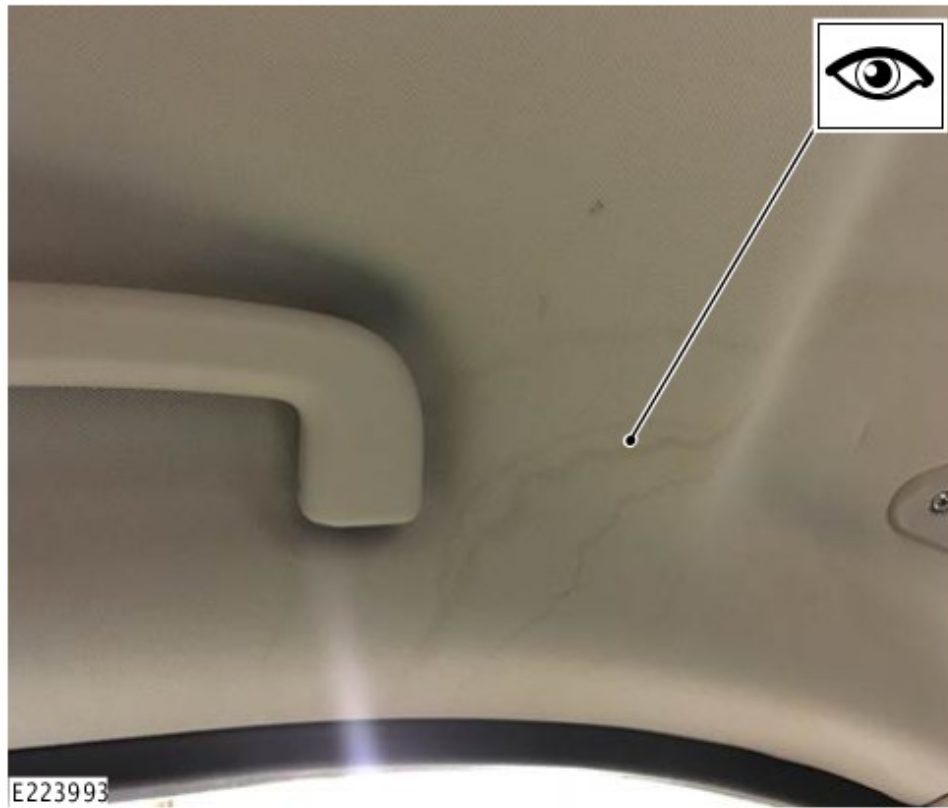
1

Water leaking may be evident through the upper area of the A-Pillar and into the passenger compartment.

This may be caused by certain body panels have been manufactured away from the required specification and, in some cases, the required body sealant has not being applied in the optimum location to prevent the ingress of water.

Example of water ingress through the A-pillar.
