Reference	SSM73855
Models	Range Rover Velar / L560
Title	Steering Column rake & reach inoperative
Category	Chassis
Last modified	16-Apr-2018 00:00:00
Symptom	303000 Steering/Handling
Attachments	Steering column electrical connectors1.pdf

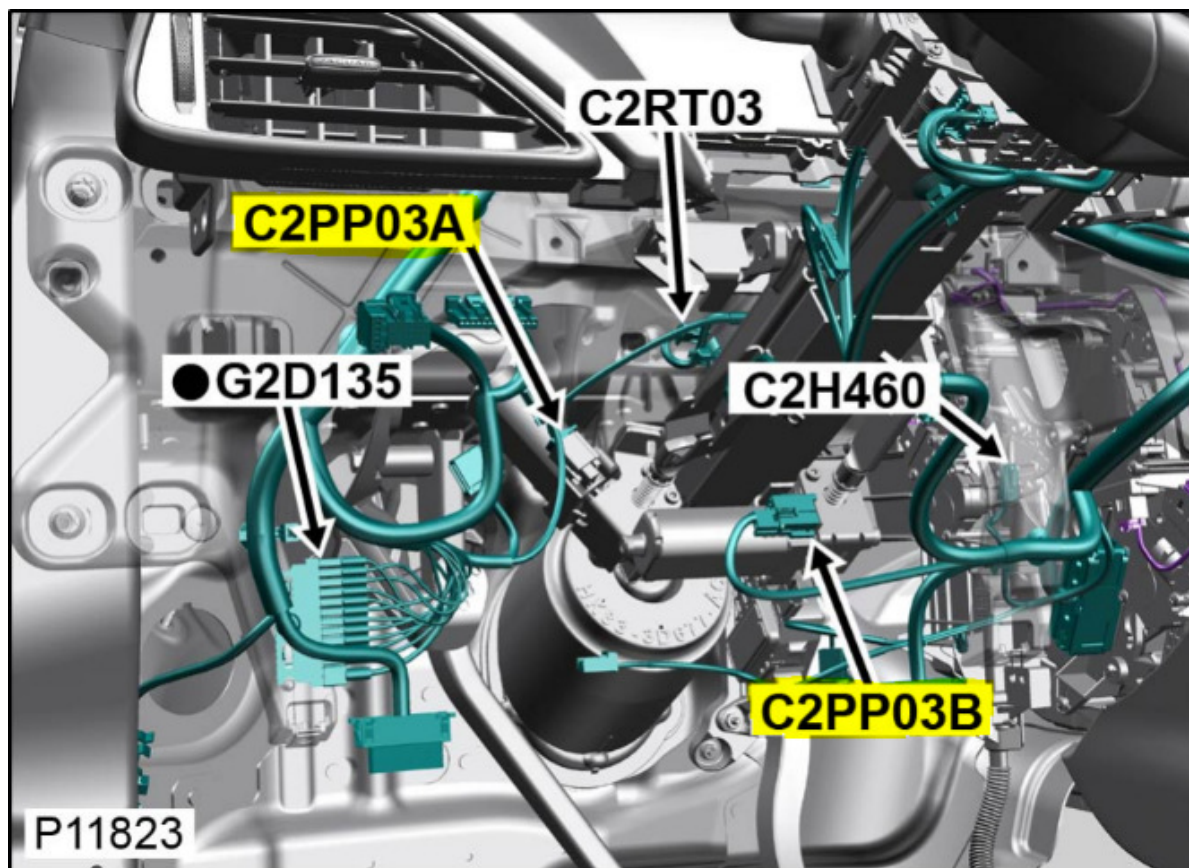
Issue: A Customer may report their steering column does not move when trying to adjust in an up/down or in/out movement.

1. Connector issue between electrical harness and steering column motors.
2. Steering column lost position, which result in no steering column movement in either, or both directions.

1. Disconnect and reconnect both connectors located on column adjustments motors, underneath the column, as shown in the attachment. Ensure an audible click is heard when reconnecting, thus ensuring correct latching of the harness connectors into the female part located on the motors. Apply a slight pull force over check on the male harness connector, to ensure a robust connection is made
2. Clear any DTC's.
3. Run the steering column calibration routine using the approved diagnostic equipment ensuring correct adjustment function.
4. Adjust the column in all directions to confirm full functionality.
