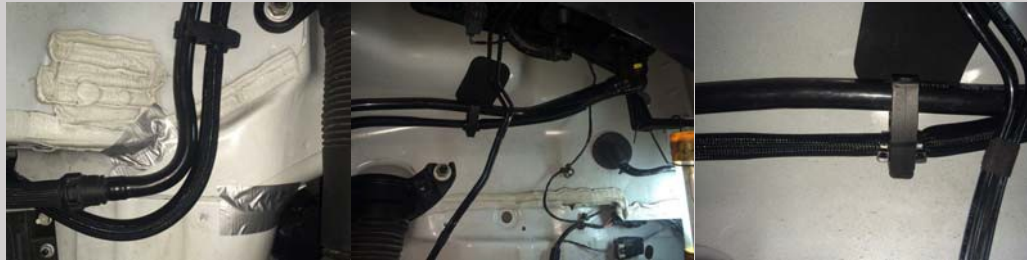
The customer may experience a high pitched noise while driving.

The noise may be perceived as coming from the front of the vehicle. Inspect the purge line between the charcoal canister and purge valve in the left rear wheel arch and manipulate the line routing. If the noise is eliminated, the position can be held using cable ties.

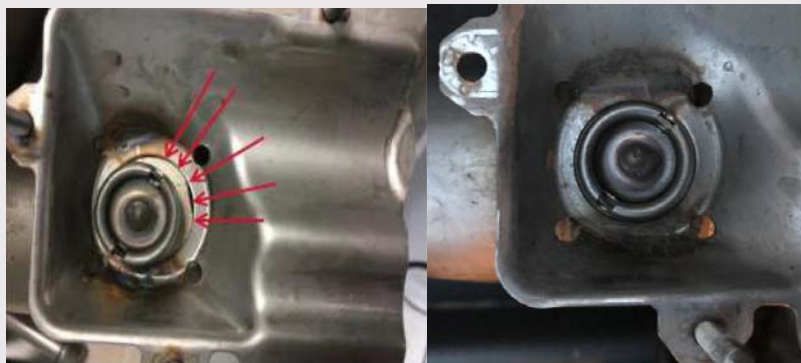
A customer may experience a Check Engine Lamp (CEL) illumination or a "Restricted Performance Message displayed on the Instrument Cluster.

Diagnosis reveals a DTC P2170-11 stored in the PCM. Remove the Exhaust Pressure Regulator Vent solenoid and inspect the alignment of the heat shield on the exhaust. If the heat shield is incorrectly aligned, replace the rear exhaust section. If alignment is correct, please raise a TA for diagnostic support after completion of primary and secondary diagnostics.

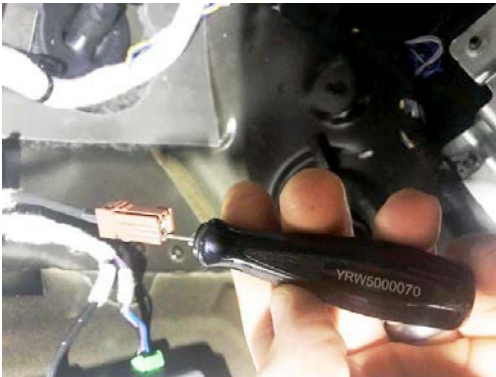
Investigation: UPON INVESTIGATION, I REALIZED THAT ALTHOUGH WE WERE UNABLE TO SOURCE A DONOR REAR CAMERA FROM A SINGLE CAMERA SYSTEM, ALL THE CAMERAS IN THE SURROUND SYSTEM OF MY SUSPECT VEHICLE ARE THE SAME CAMERA. I DEPINNED THE CONNECTOR FOR THE LEFT MIRROR CAMERA AT THE IMAGE PROCESSING MODULE (SEE PHOTOS, POP THE WHITE RETAINER UP AND THEN USE YRW5000070 TO RELEASE CONNECTOR) AND SWITCHED THE BARE CONNECTOR INTO THE SPOT FOR THE REAR CAMERA, THEN SELECTED REVERSE. I WAS ABLE TO VERIFY I HAD A PROBLEM FROM THE HARNESS BACK TO THE CAMERA WHEN REVERSE BROUGHT THE KNOWN GOOD LEFT MIRROR IMAGE ONTO THE SCREEN.

**Special tool YRW5000070 to pop up the white retainer to release the connector shell. Note this can be done at the IPMB or at the camera itself.**

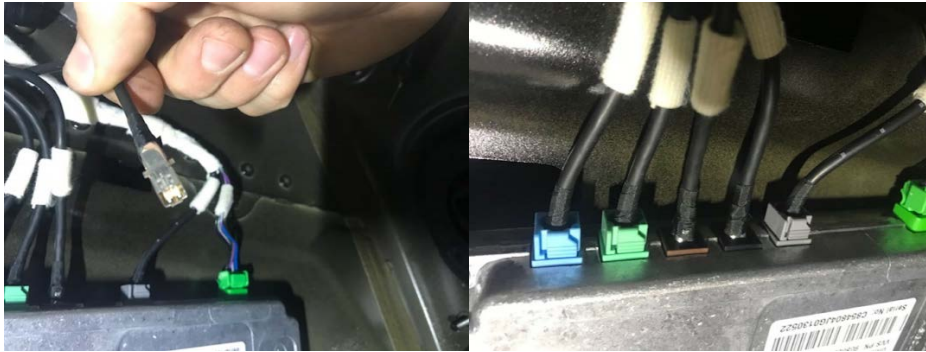
**Camera lead shown with connector shell removed.**

**Without the connector shells the leads can be swapped at the IPMB**

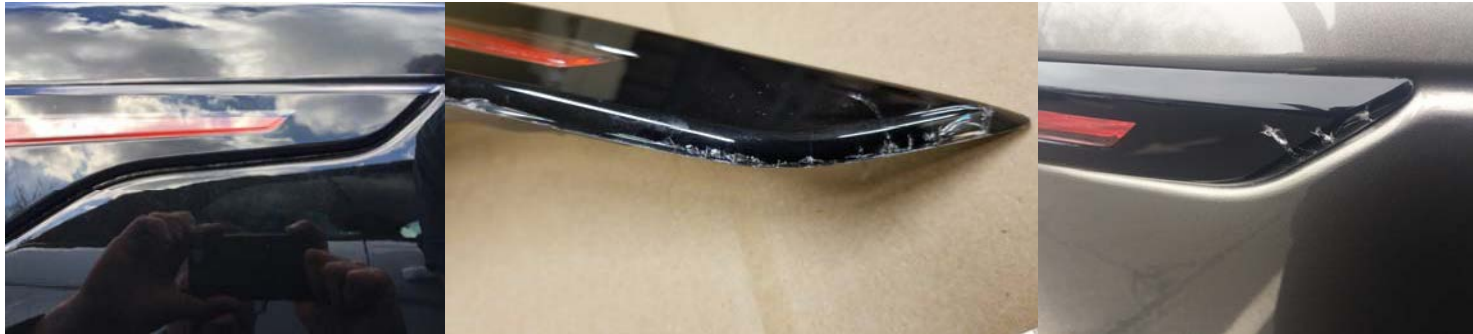
A Customer may report that the tail lamp appears to be delaminating or cracking.

Engineering are currently investigating cases where the tail lamps appear to be delaminating or cracking. Please report any cases you find of this concern via EPQR with pictures of the tail lamp concern and the date codes on the back of the lamp assembly to support the investigation,

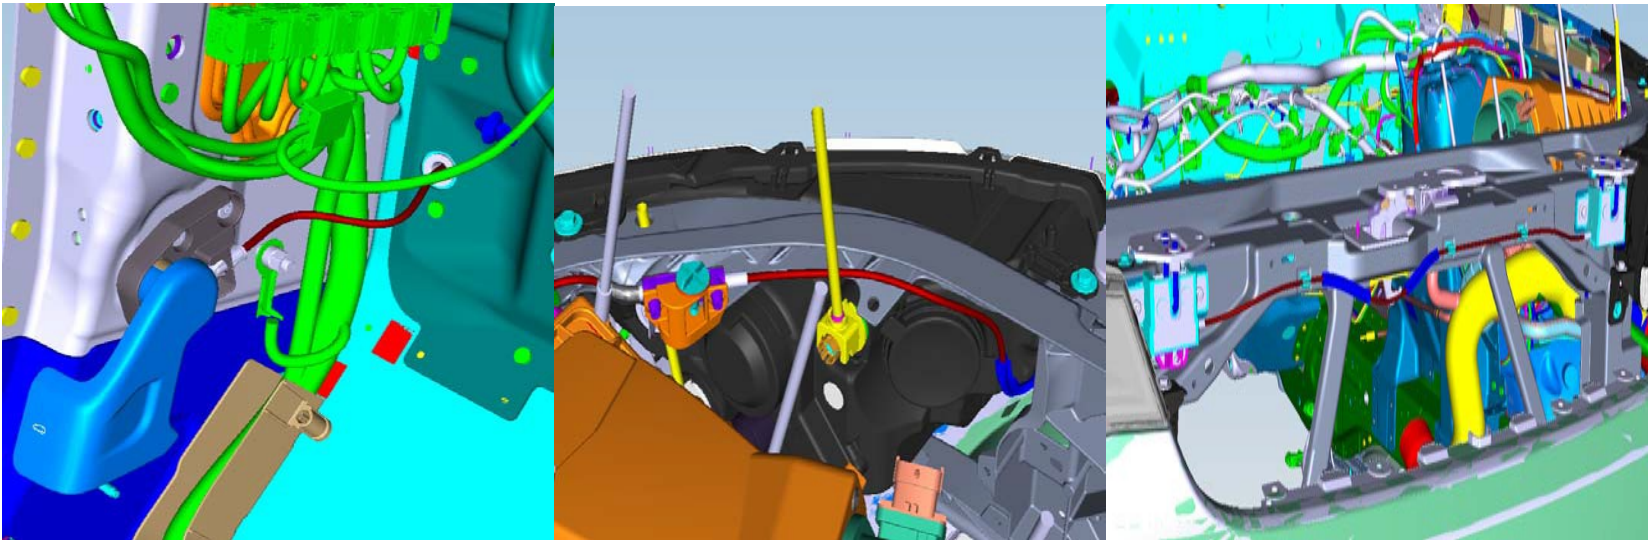
Customers may report the hood is difficult to open.

Engineering is currently investigating a concern where the hood release level is pulled fully, but either one or both of the hood latches does not release. Further pulling of the release cable releases the latches. This may be caused by the hood cable routing. Engineering is requesting that the hood cable routing be inspected prior to removal or replacement of the cable. Specifically checking the radius of the cable bends. Should a customer express a concern, please submit an EPQR with pictures of the cable routing prior to any removal of the cable.
