Service Information Letter

Date: May 7, 2018

Units Affected: DC Series Derricks with Controls Below Rotation (see attached list)

Slip Ring Inspection

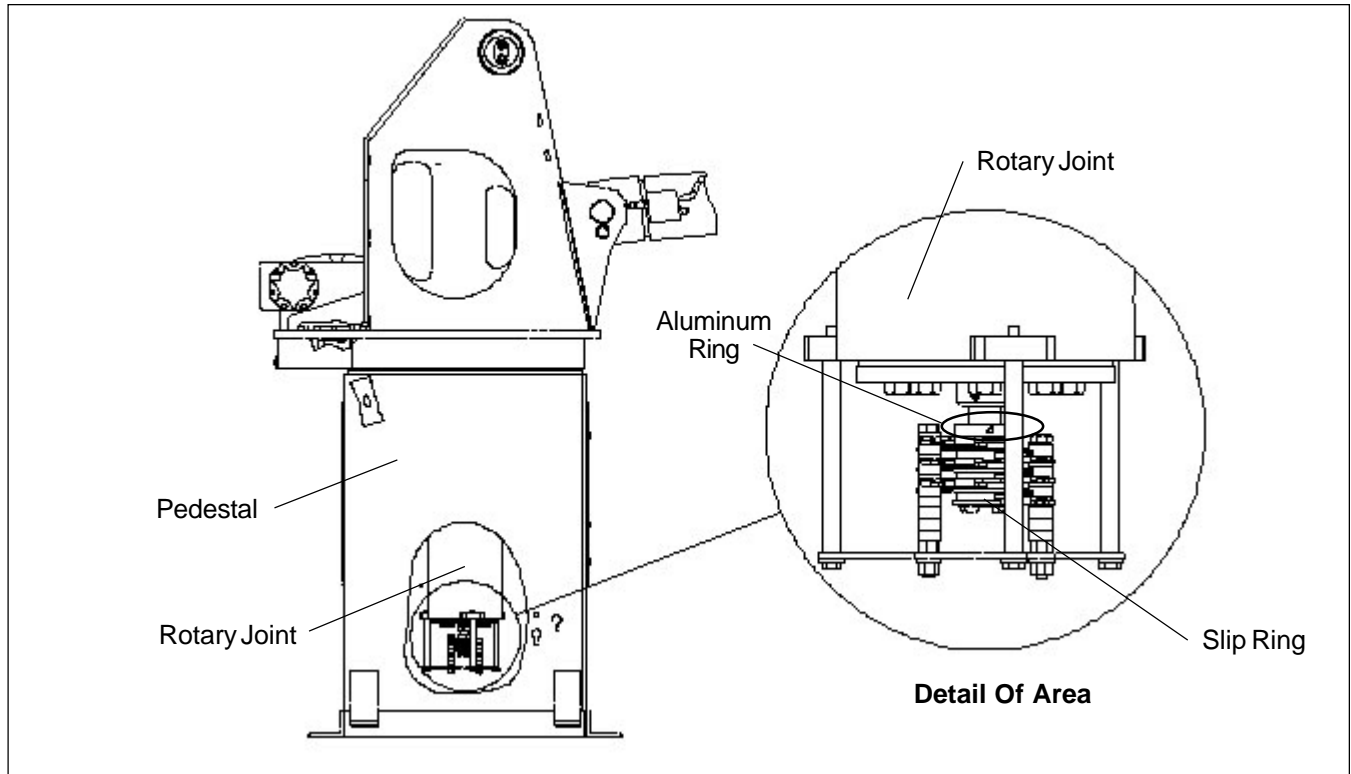
Figure 1 — Slip Ring Mounting

1. Remove the covers from the front and back of the pedestal to allow access to the rotary joint and slip ring.
2. Grip the aluminum ring at the top of the slip ring (refer to Figure 1) and try to turn it clockwise and counter clockwise. If the ring cannot be turned, go to Step 3. If the ring can be turned, go to Step 5.

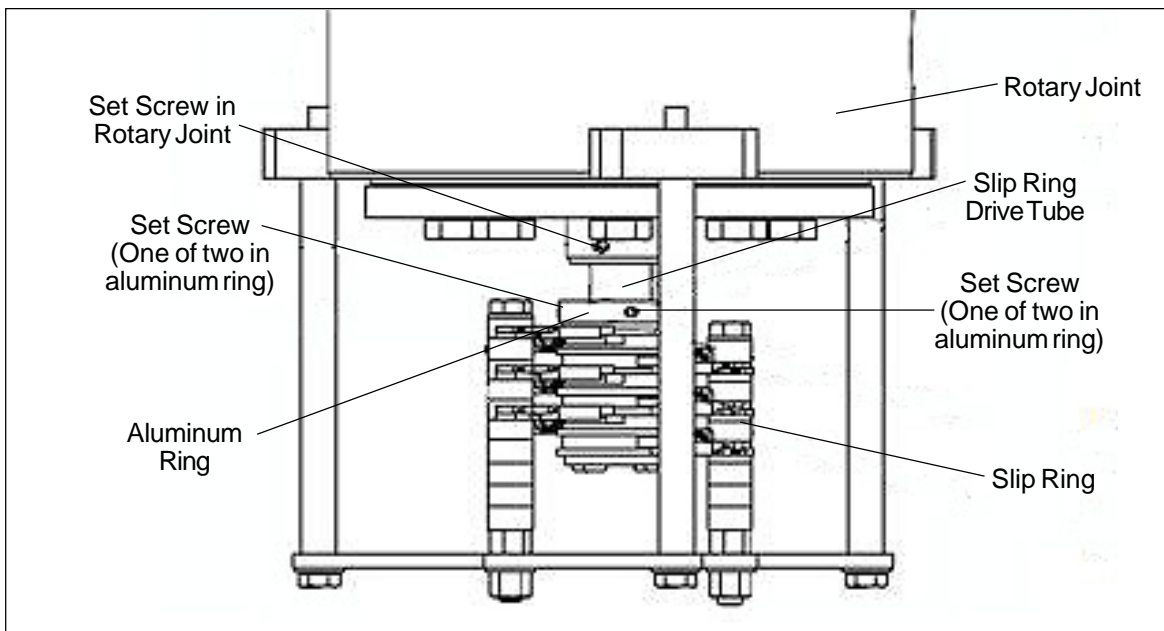
Figure 2 — Set Screw Location

3. Check to see if there is a set screw in the tapped hole in the boss on the bottom of the rotary joint (refer to Figure 2). Insert a $\frac{1}{8}$ " Allen wrench in the hole and try to engage the hex socket of the set screw. If the Allen wrench engages a set screw in the hole, go to Step 4. If there is no set screw in the hole, the slip ring is improperly installed, continue on to Step 5.

4. Use a $\frac{1}{8}$ " Allen wrench to make sure the set screw in the boss on the rotary joint is tightened snugly against the slip ring drive tube. Use a $\frac{3}{32}$ " Allen wrench to make sure both set screws in the aluminum ring at the top of the slip ring are tightened snugly against the drive tube. After all the set screws are in place and tight, the slip ring is now properly installed. Continue to Step 6.
5. If the aluminum ring at the top of the slip ring can be turned by hand or there is no set screw in the hole, the slip ring is improperly installed and it must be replaced. Order the Slip Ring Replacement Kit, part number 990590165, by calling 1-877-GO ALTEC (1-877-462-5832). If a wire breaks before the slip ring is replaced, the unit can stop operating or accessories above rotation may not work.
6. Reinstall the covers on the pedestal and return the unit to service.
