**Water Leakage onto the Front Floorboard?**

Year	Model	Trim
2014-17	MDX	ALL

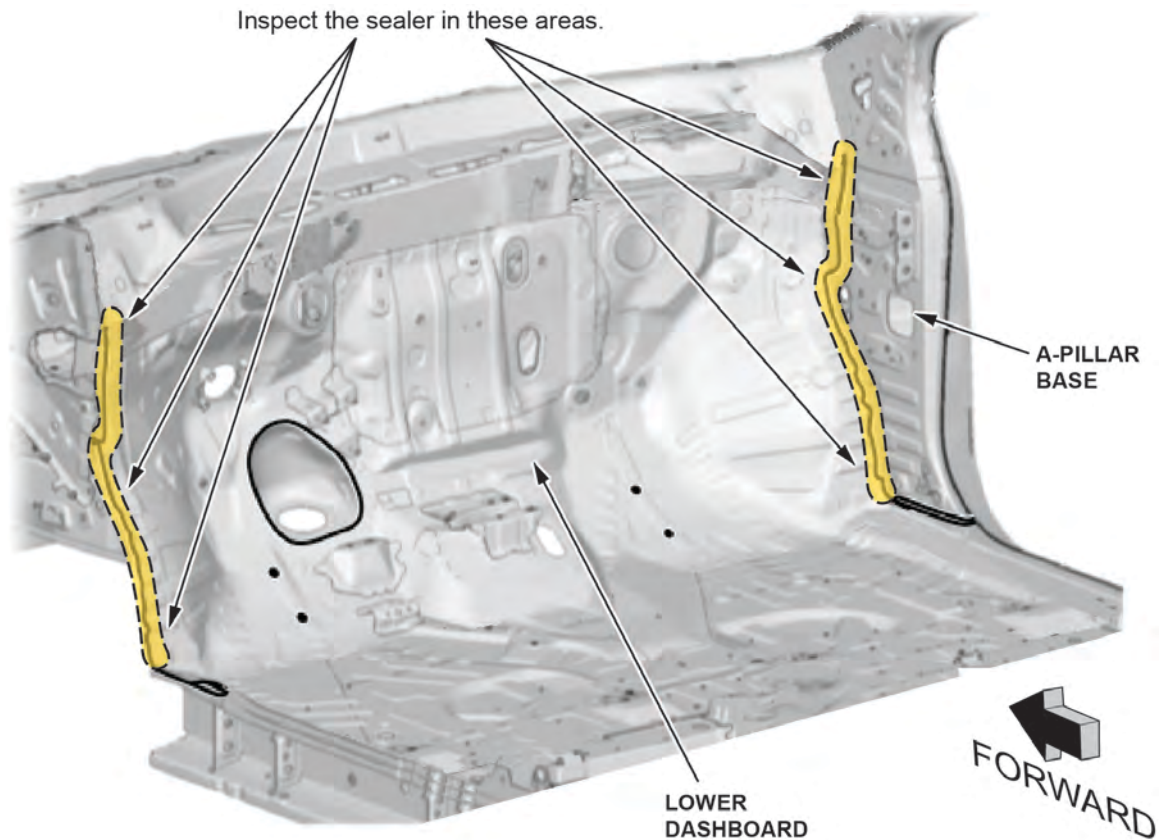
The area where the lower dashboard meets the A-pillar base has sealer that's applied by automation. But because that automation can't reach every nook and cranny, someone must then spread the sealer with a small squeegee.

This can result in pin holes in the sealer or the sealer even being pulled away from the area. Under wet conditions, this can cause water leakage onto the front floorboard on the driver's and/or front passenger's side.

If you get a vehicle in for this, be sure to check the seam sealer in that area when you're doing water testing. If the sealer has a hole, is incomplete, or missing, thoroughly clean the area, remove any sealer that's loose or damaged, then reseal the area.
