GROUP	NUMBER
CAMPAIGN	18-01-021
DATE	MODEL(S)
JUNE, 2018	ELANTRA TOURING
	(FI))

INSTRUMENT CLUSTER LCD SCREEN INSPECTION AND REPLACEMENT (SERVICE CAMPAIGN T2N)

This TSB supersedes TSB 17-01-067 to add a step advising the reinstallation of the instrument cluster blue LED light cover.

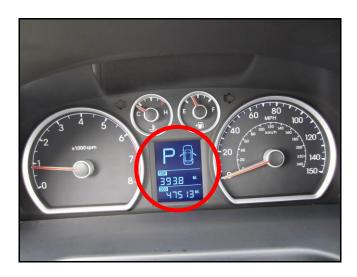
Description: On certain 2012 Elantra Touring (FD), the LCD screen display in the cluster may exhibit no illumination. If there is no illumination, the odometer, gear selection, and door ajar information will not be visible by the driver.

This bulletin describes the service procedure to replace the LCD screen to correct the display condition.

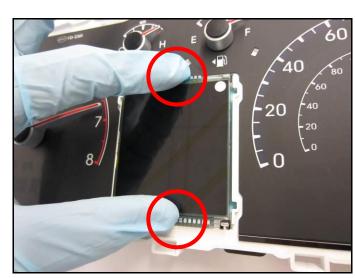
The LCD screen only requires minimal pressing force to be fully seated. If it does not seat smoothly, then two pins were seated into one hole. Simply remove the LCD screen, adjust the pins, and reinstall.

Do not press at the center point of the LCD screen. Pressing at the center point may cause the LCD screen to crack.

9. Gently press down on the two locations as shown in the picture.
