Reference	SSM73349
Models	Range Rover Evoque / L538
Title	L538 - Rear Window Washer jet - In-operative
Category	Body
Last modified	10-May-2018 00:00:00
Symptom	102000 Window/Glass
Attachments	1Attachment5.pdf

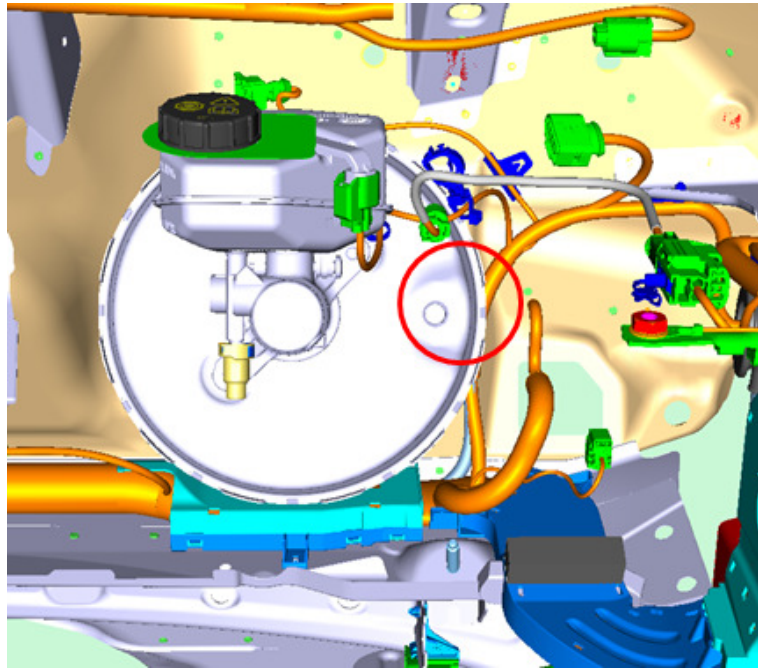
Fig. 1

Various trap conditions can restrict the flow of fluid through the washer jet hose to the tailgate washer jet.

- Pay particular attention to the area around the brake booster, see Fig.1.

Verify and locate the cause of the customer concern then, with the help of the attachment: -

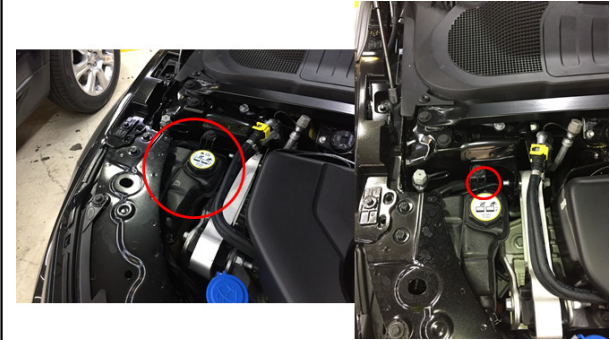
Fig. 2

- Check the area beneath the coolant expansion tank. These locations can be seen in Fig.2 and Fig.3.
