Discovery
Sport 18MY

A customer may experience a Check Engine Lamp (CEL) illumination or a "Restricted Performance Message displayed on the Instrument Cluster.

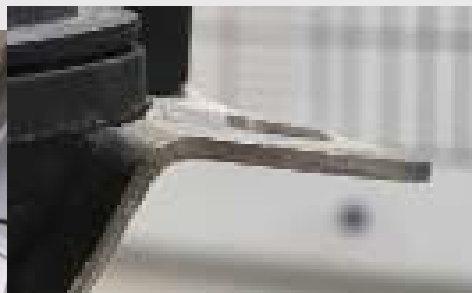
Diagnosis finds DTC P2170-11 "Exhaust Pressure Regulator Vent Solenoid Control Circuit Low" stored in the PCM. Inspect the heat shield for proper alignment compared to the valve in the pipe (see image) and for any damage to the mounting points of the solenoid. If misalignment or damage is identified, replace the rear section of exhaust.

If neither above is identified, perform diagnosis as outlined in TOPIx and raise a TA if additional diagnostic support is required.
