Reference	SSM73584
Models	Discovery Sport / L550 Range Rover Evoque / L538
Title	L550 & L538 17MY Active Driveline Noise/Vibration
Category	Driveline
Last modified	16-May-2018 00:00:00
Symptom	597997 Driveline Noise Concerns
Attachments	11Image 1.JPG 11Image 2.jpg

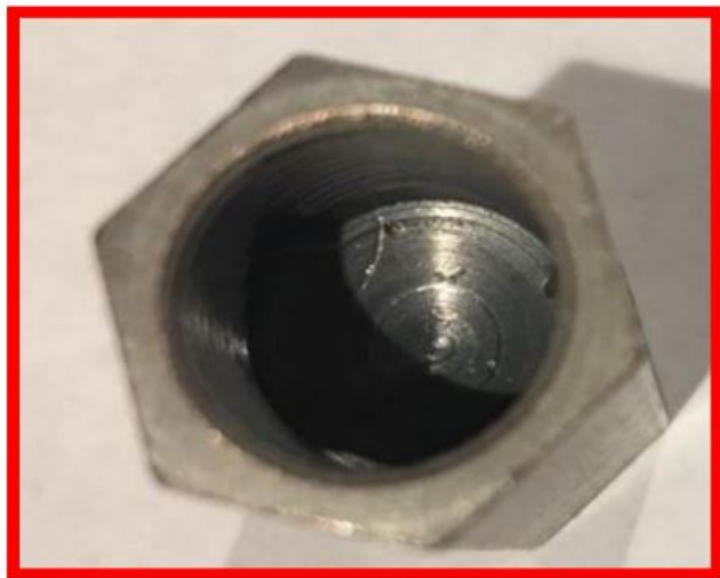
NOK

A small number of vehicles may have been produced with a non-drilled union (**See Image 1**) in the hydraulic lines between the Power Transfer unit (PTU) and the Rear Drive unit (RDU). This is causing a restriction in the hydraulic line.

If a restriction is found in the union please replace the hydraulic line as listed below and submit an EPQR.

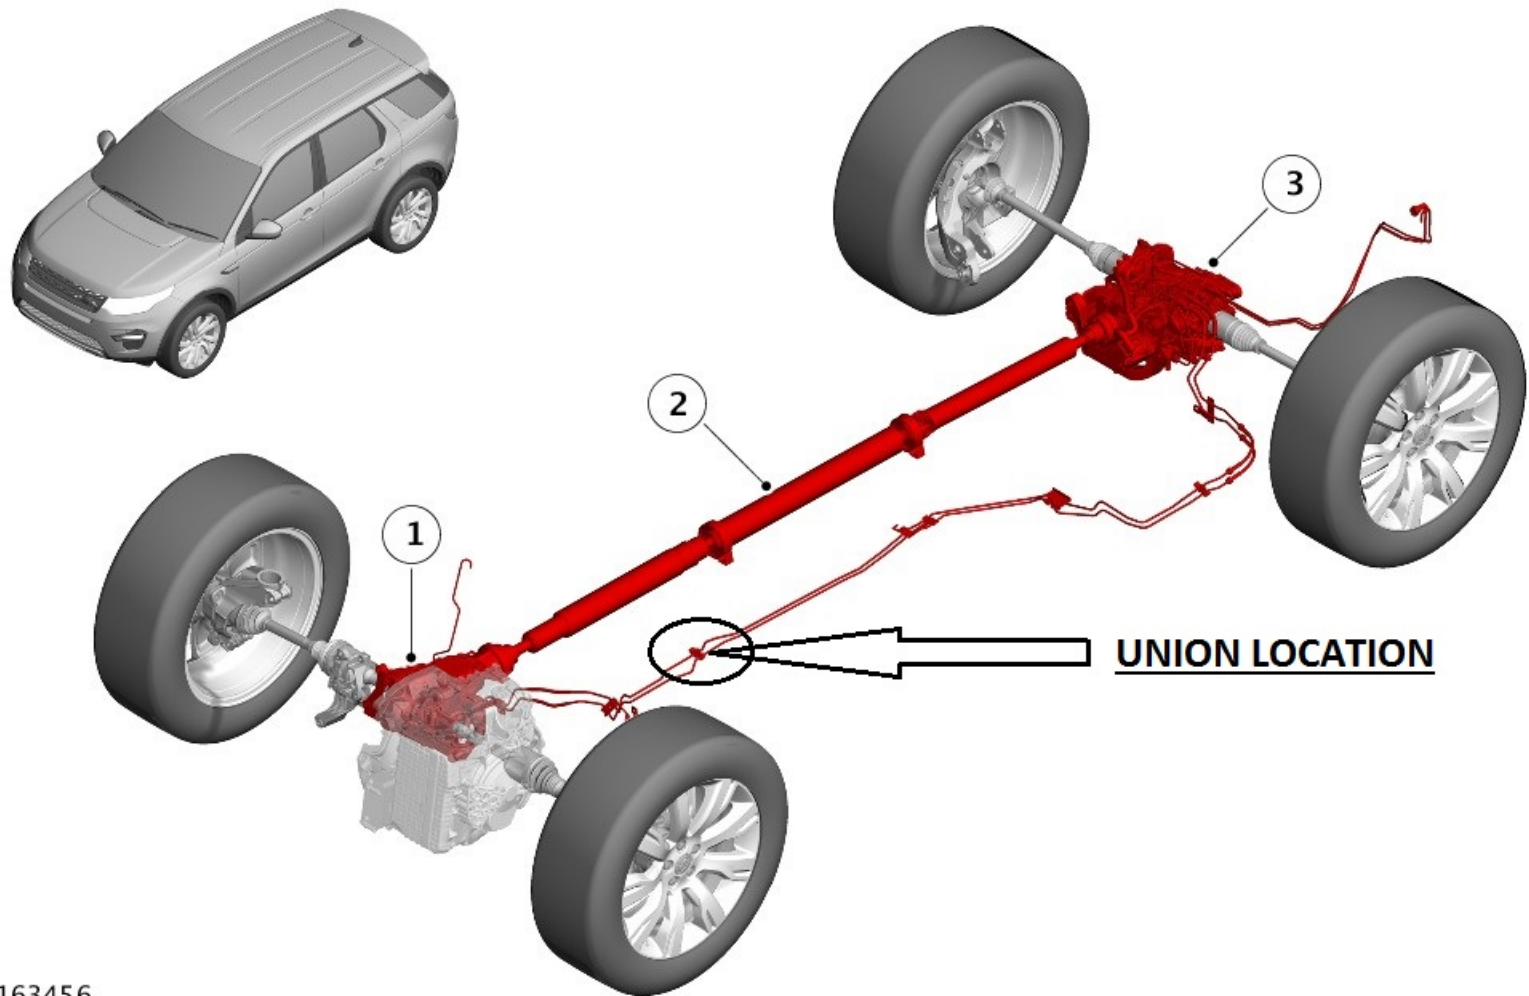
If a customer presents their vehicle exhibiting the above symptom please ensure that the union is clear of restrictions in the location shown in **Image 2**.
