Reference	SSM73458
Models	Discovery Sport / L550 Range Rover Evoque / L538
Title	L550 Discovery Sport & L538 Evoque - Door rattles
Category	Noise Vibration
Last modified	16-May-2018 00:00:00
Symptom	702000 Other Noise Concerns
Attachments	11Fig 1.pdf 11Fig 2.pdf

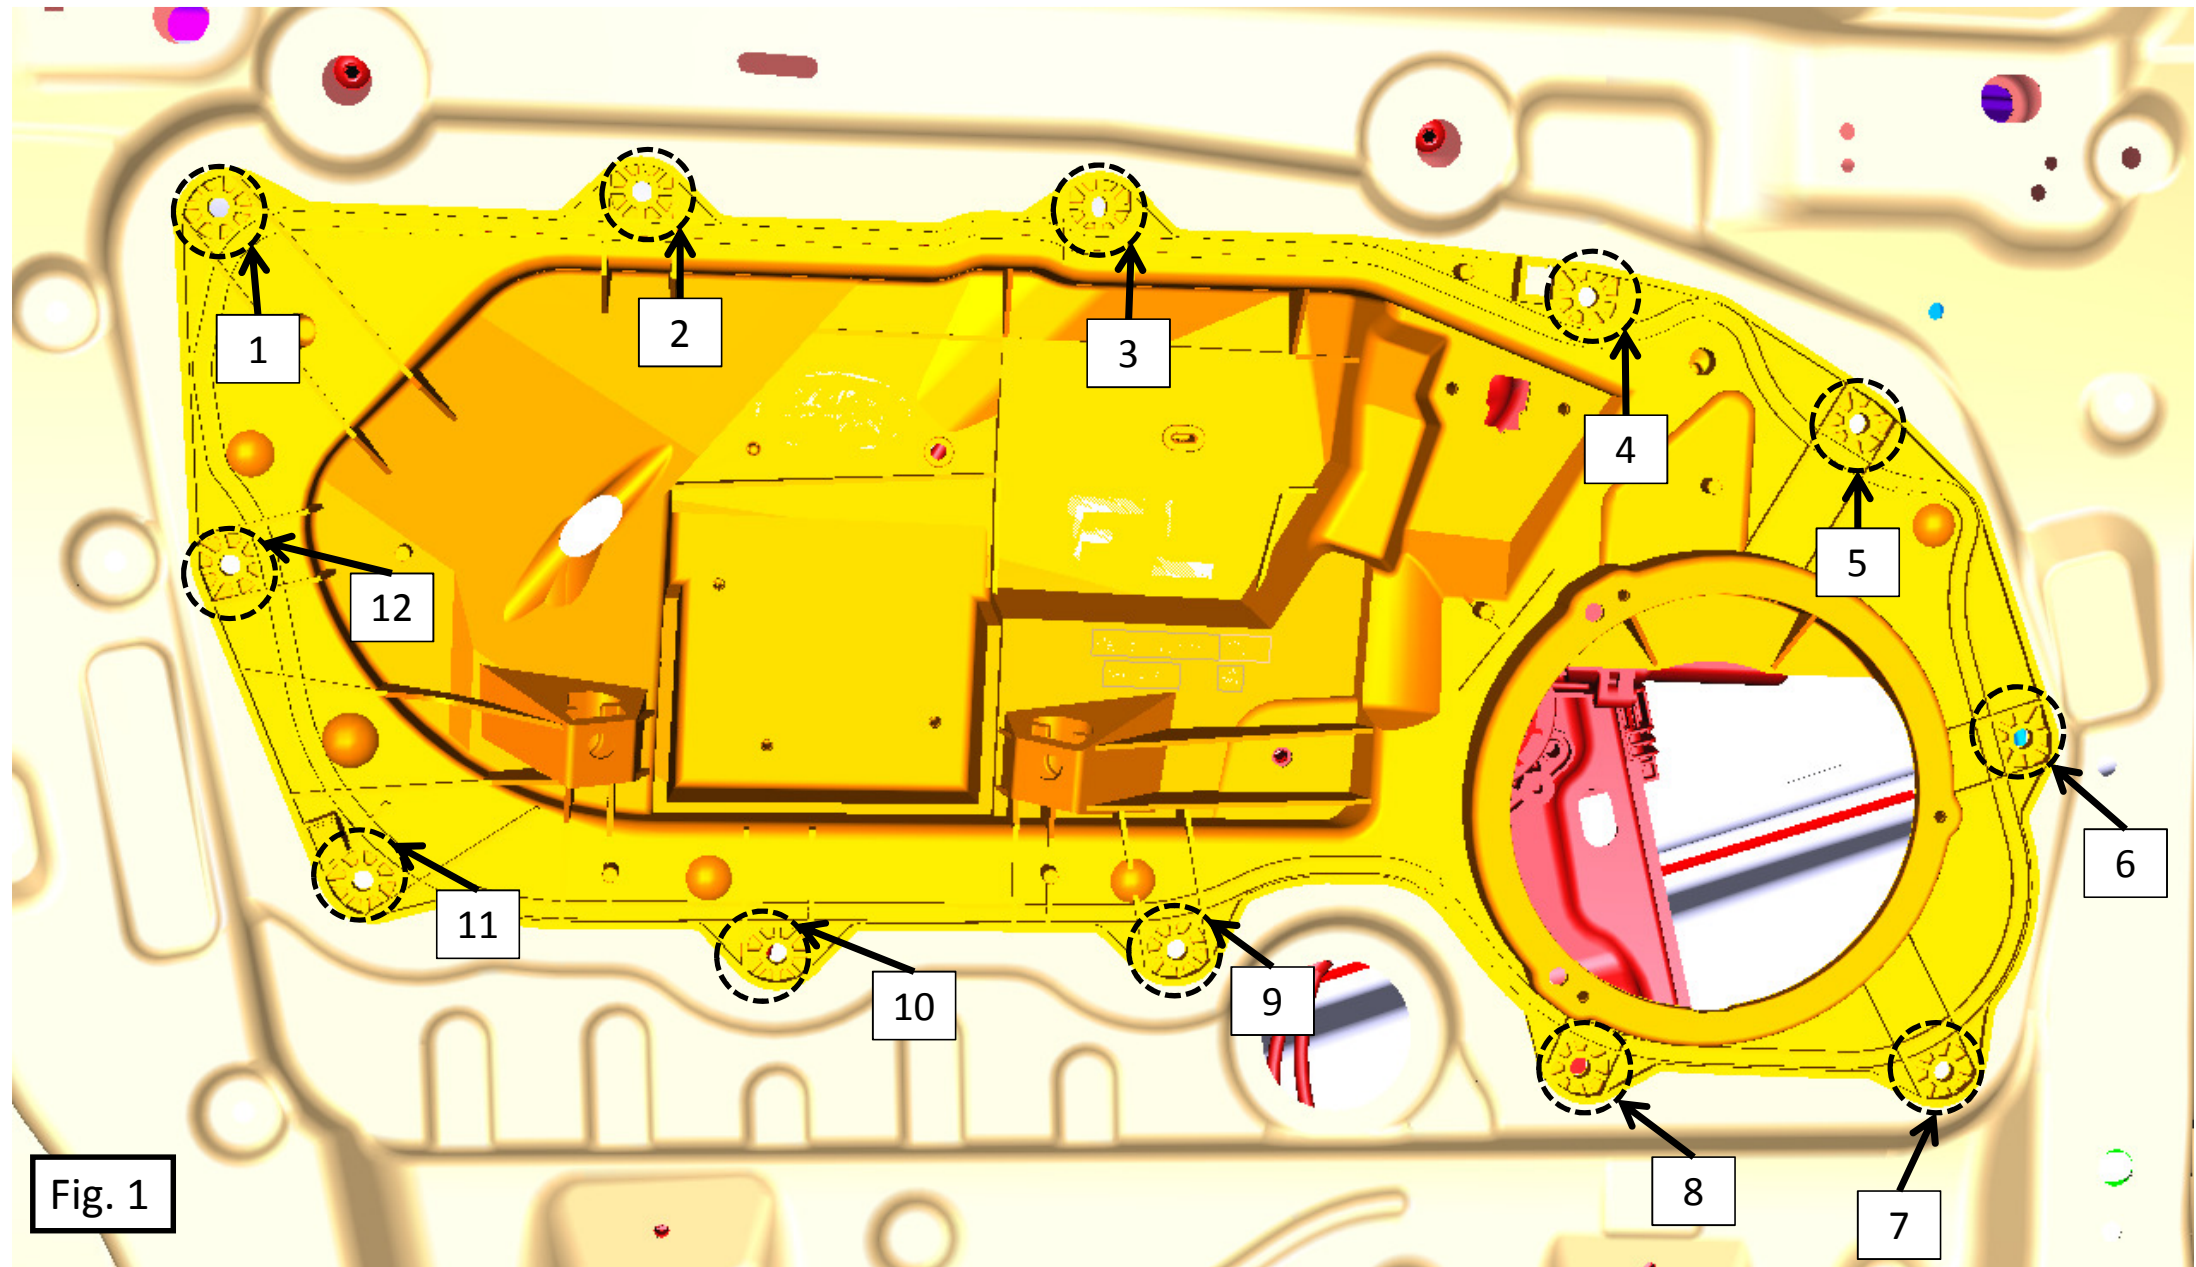
Fig. 1

Content Issue: Customers are reporting a door rattle from one or more doors.

Cause: Loose fixings are being reported but further detail is required.

- Fig 1 = Plastic closure plate fixings, situated behind the door card (fixings 1 - 12).
- Fig 2 = Regulator frame fixings (fixings 13 – 17).

Action: Please see the attachments and raise an EPQR that references which fixing(s) is loose. Recommend torque values for all fixings are 2Nm +/-0.1Nm.
