Reference	SSM72901
Models	LR3 / L319 Range Rover / L405 Range Rover Sport / L494
Title	8HP70 Automatic Transmission Oil Leak 15-16MY
Category	Driveline
Last modified	16-May-2018 00:00:00
Symptom	501000 Automatic Transmission Concerns
Attachments	11Porous Transmission Housing.pdf

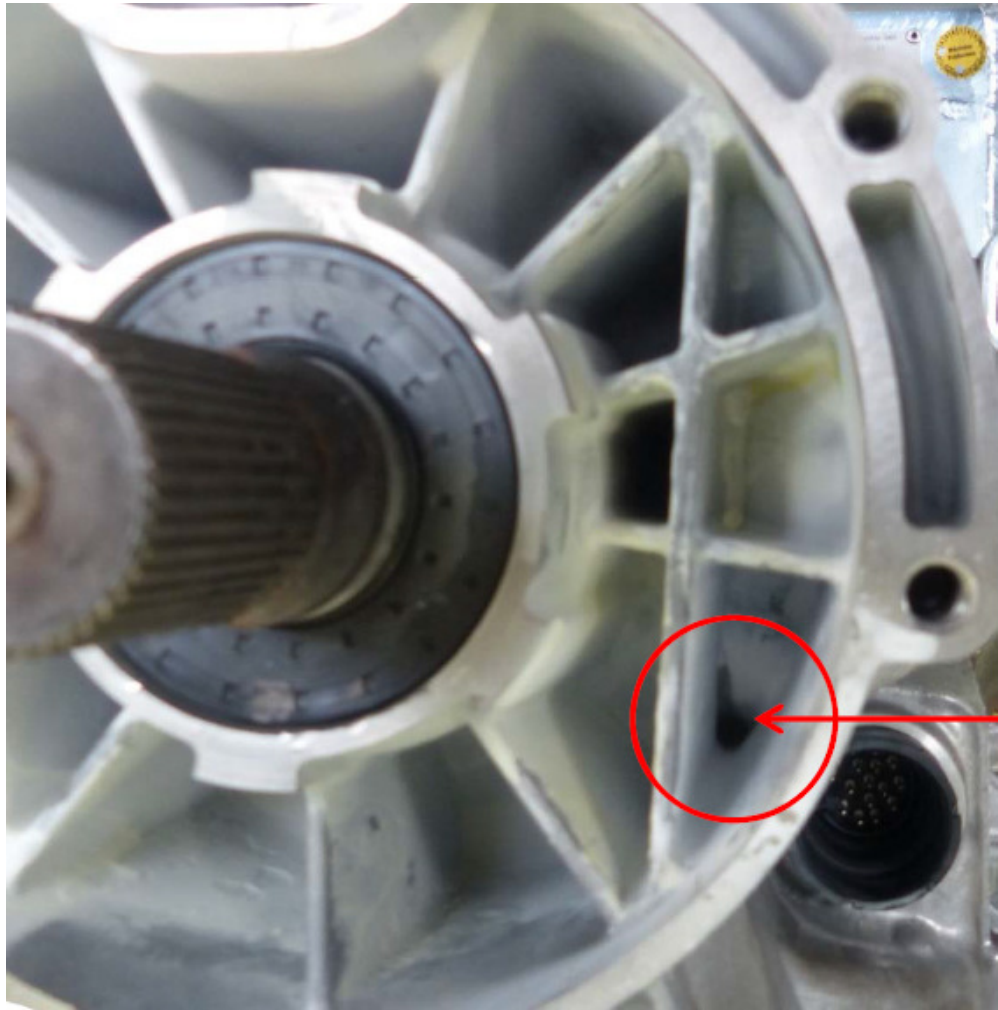
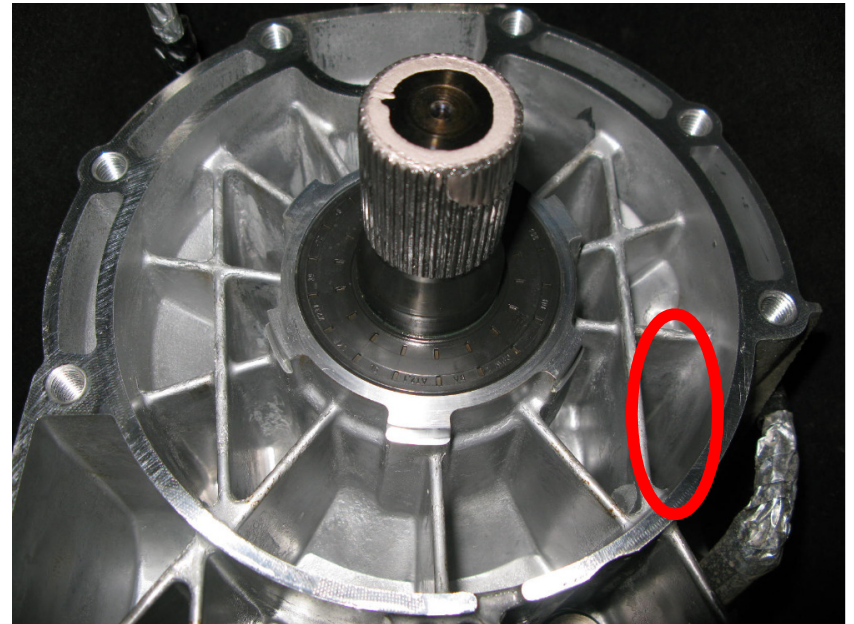
Oil weeps through the aluminium of the casing in the base of the pocket around where the steel D clutch tube is embedded, refer to attached file.

Internal porosity in the area of the extension casing allows oil to reach the end of the small pocket under the tube where it is prone to casting skin damage during casting. Oil then drips from the drain hole in the space between the transmission and transfer box.

Area of leak

Remove the transfer case and inspect the area as shown in the attached file. If a leak is confirmed in this area, submit a FRED for an automatic transmission replacement attaching clear photos confirming the issue.
