LTB01140NAS2

TECHNICAL BULLETIN

204-02: Rear Suspension

Boom Noise Heard In The Passenger Compartment

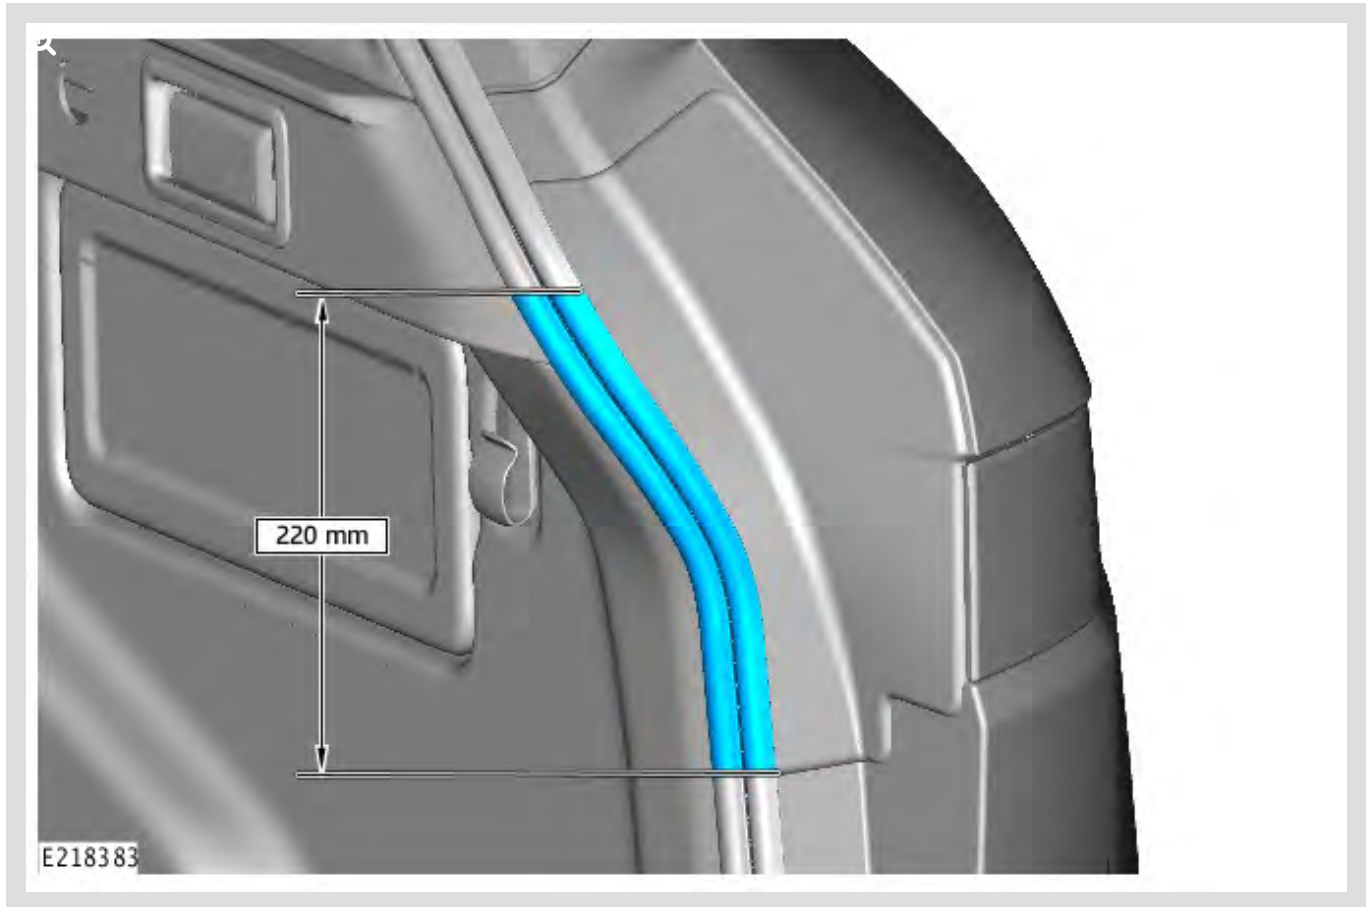
Squeeze the tailgate seal for a foam insert in the highlighted area.

- If the foam insert is present, **go to Workshop Procedure 'C'**.
- If the foam insert is **NOT** present, **go to Step 2** .
