N199NAS1

TECHNICAL BULLETIN

418-02: Wiring Harnesses

Service Action: Left Hand Drive (LHD) Engine Wiring Harness Not Secured

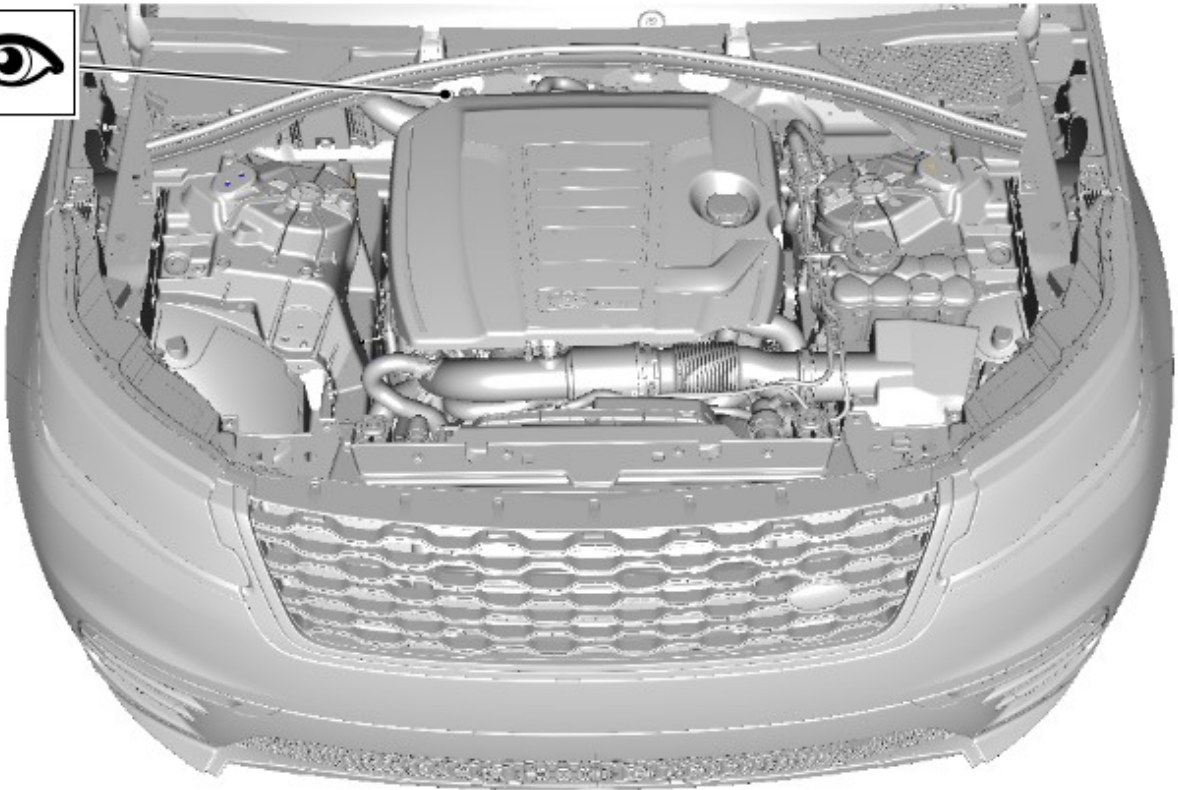
E227103

An issue has been identified on a limited number of vehicles within the listed Affected Vehicle Range where the underhood/engine compartment harness may not be secured, which could lead to abrasive damage and electrical faults.

The illustration shows the location of the component.
