Volvo Model VNR , VNX , VNL , VNM , VHD , VAH

Title Volvo Chassis - Equipped With An Automated Manual Transmission Model D or F (I-Shift, AMT-D, AMT-F) - Transmission Oil Leakage From Transmission Input Shaft Seal Or Output Shaft Seal - **US10 And Newer Emissions, Common Model Years 2010 And Newer**

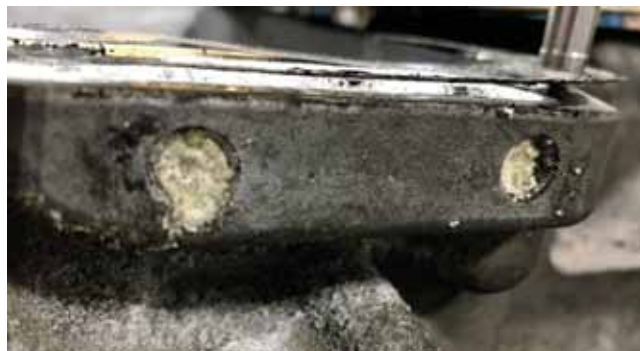
Cause Accumulation of debris in the left side vent ports of the transmission main case (corrosion, road salt, dirt, etc) may result in oil leaks present at the transmission input and output shaft seals.

Blockage of these ports allows pressure to build to a point that it forces oil past the input and output shaft seals. In extreme cases, the pressure buildup can be high enough that operation can be affected. Excessive internal pressure caused by blocked vents may result in slow or sluggish gear shifts.

Clogged vent ports

1. Check the vent ports on the upper left side of the the main gearbox housing for any sort of blockage or obstruction.

2. Clean out any debris that is observed during the inspection.
3. Coat the surfaces lightly with high temperature grease. This will help prevent future buildup or corrosion.
4. Check the transmission oil level in the gearbox.
 - **If the lube level is excessively low:** Proceed to the next section.
 - **If the lube level is at an acceptable level:** Fill the transmission oil to the correct level and check operation.
