SUBARU

NUMBER: 07-131-18R

SERVICE BULLETIN

SUBJECT: Stop Lamp Switch / Pedal Stroke Adjustment

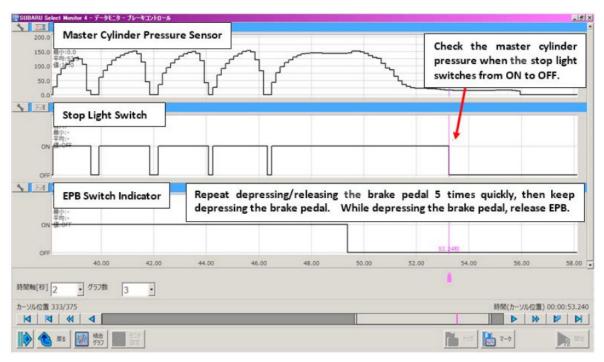
- **d)** Without depressing brake pedal, make sure the stop light switch shows OFF on the SSM-4 data monitor.
- e) Depress and release the brake pedal 5 times quickly, then hold pressure on the brake pedal.
- **f)** While depressing the brake pedal, release EPB.
- g) After releasing EPB, gradually release the brake pedal and note the value for master cylinder pressure when the stop light switch turns from ON to OFF. The specification is less than 15 bar (1.5 MPa). See the screen shot below for reference.
- **h)** If the master cylinder pressure is out of specification, continue DTC C1531 diagnosis following the procedure in the applicable Service Manual. If the value is within specification, the procedure is complete.
