SERVICE BULLETIN

APPLICABILITY: 2015-2018MY WRX and WRX STI Models **NUMBER:** 12-243-18
SUBJECT: Paint Chipping between Hood Grille (Scoop) and Hood **DATE:** 06/06/18

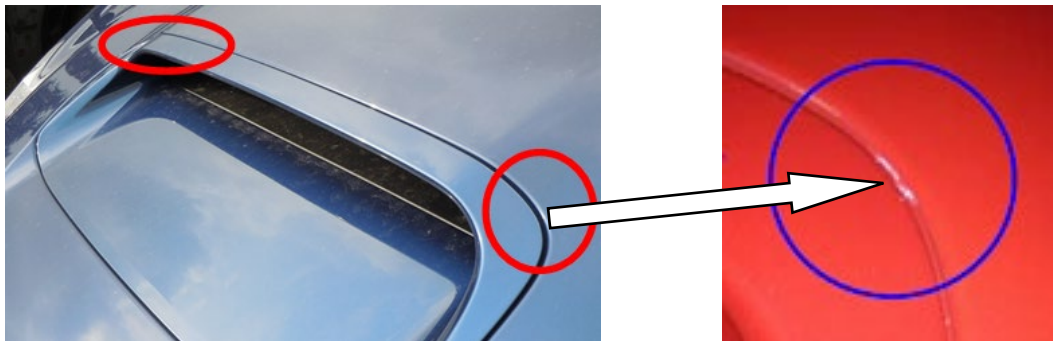
This bulletin replaces TSB **12-201-16R** and provides a new repair procedure to address customer concerns of the hood scoop scrubbing the finish of the hood panel in the areas shown in the photo below. Due to different expansion rates between the metal hood panel and the resin material used for the hood scoop, the edges of the scoop's rear corners may come in contact with the hood panel and abrade the finish.

The procedure involves installation of a new hood scoop assembly which includes re-designed Sealer Tapes to eliminate contact between the scoop and hood panel.

1. **CAREFULLY** remove the inner hood duct and scoop following the procedure in the applicable Service Manual.
2. Repair any abraded paint on the hood using touch-up paint. If the damage is too severe for the use of touch-up paint, a body shop spot repair may be necessary. If it is believed any more involved repairs are required, consult your DPSM **before** proceeding.
