**SERVICE BULLETIN**

**APPLICABILITY:** 2018MY Crosstrek

**NUMBER:** 12-244-18

**SUBJECT:** Gapping of Rear Quarter Panel Garnish

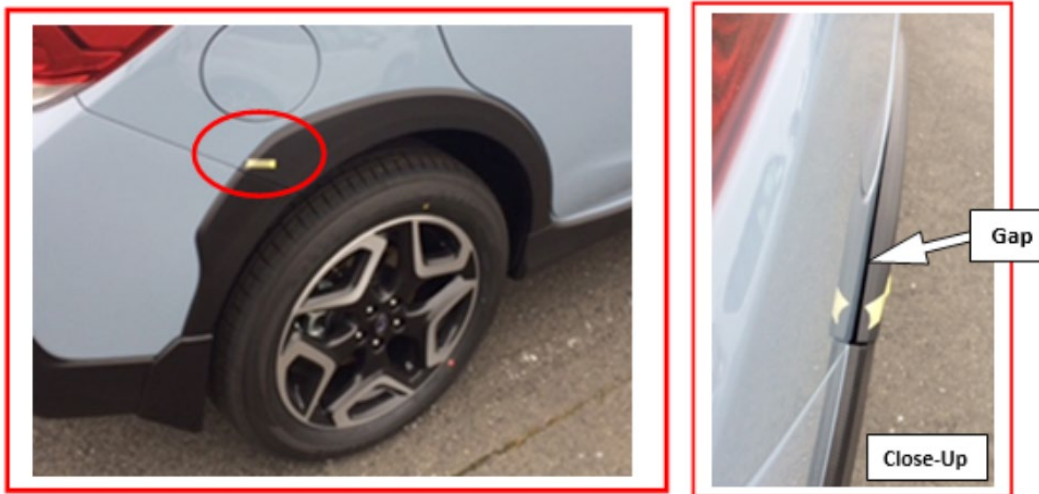
This bulletin outlines changes made to the rear quarter panel wheel arch garnish to eliminate gapping between the inner edge of the trim and the vehicle body as shown in the images below.

To address this condition, changes have been made to the retaining tab at the rear of the garnish. Details of the changes are provided in the Part Information below. The changes were phased into production at two VIN breaks:

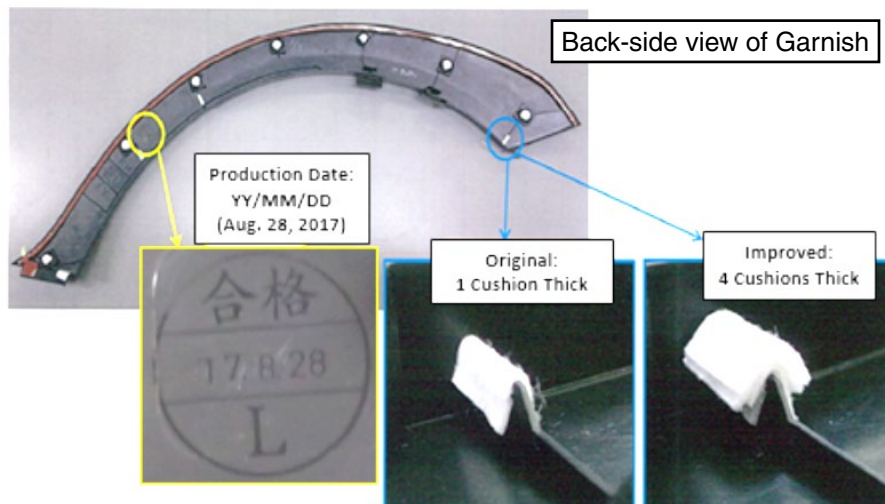
- **Change #1 (Original):** Added 1 thickness of non-woven material to the rear-most retaining tab to enhance garnish retention. These parts were produced between 5/18/2017 and 8/23/2017.
- **Change #2 (Improved):** Stack 4 thicknesses of non-woven material to the tab to further enhance retention and eliminate gapping. The tab was also extended by 1.5mm. These parts were produced on and since 8/24/2017.
