## SERVICE BULLETIN

**APPLICABILITY:** 2015-2018MY Legacy and Outback  
 2012-2018MY Impreza  
 2013-2018MY Crosstrek  
 2014-2017MY Forester  
 2015-2017MY WRX

**NUMBER:** 16-112-18R

**SUBJECT:** Ignition Key Sticking / Design Change to CVT Shifter / Selector Lever Components

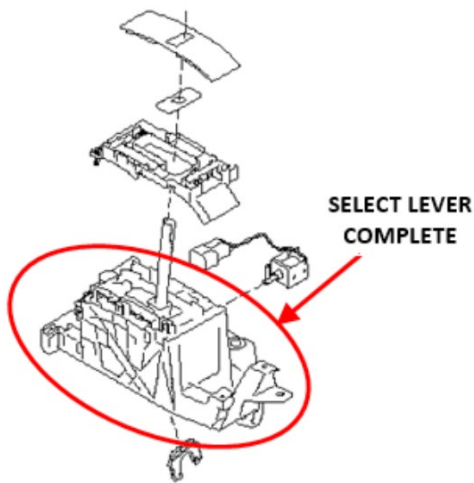
**For Legacy and Outback:**

- The term PLATE-GUIDE B refers to the Park-Range switch which is a serviceable part of the select lever assembly on all models listed above **EXCEPT** Legacy and Outback. See the illustrations provided below for more details.
- For **Legacy and Outback**, the shifter assembly (SELECT LEVER COMPLETE) must be replaced if the Park-Range switch is found to be faulty.

- Replace the SELECT LEVER COMPLETE assembly (on Legacy and Outback models) or,
- Replace the Park-Range switch (PLATE-GUIDE B) following the Select Lever disassembly / assembly procedure in the applicable Service Manual.
