**Stoughton Trailers, LLC**

May 3, 2018

### Ag Hopper Trailer – Slope Sheet Repair

Repair Document #: **SK-09435**  
Date: April 16, 2018  
Revision:  
Revision Date: N/A

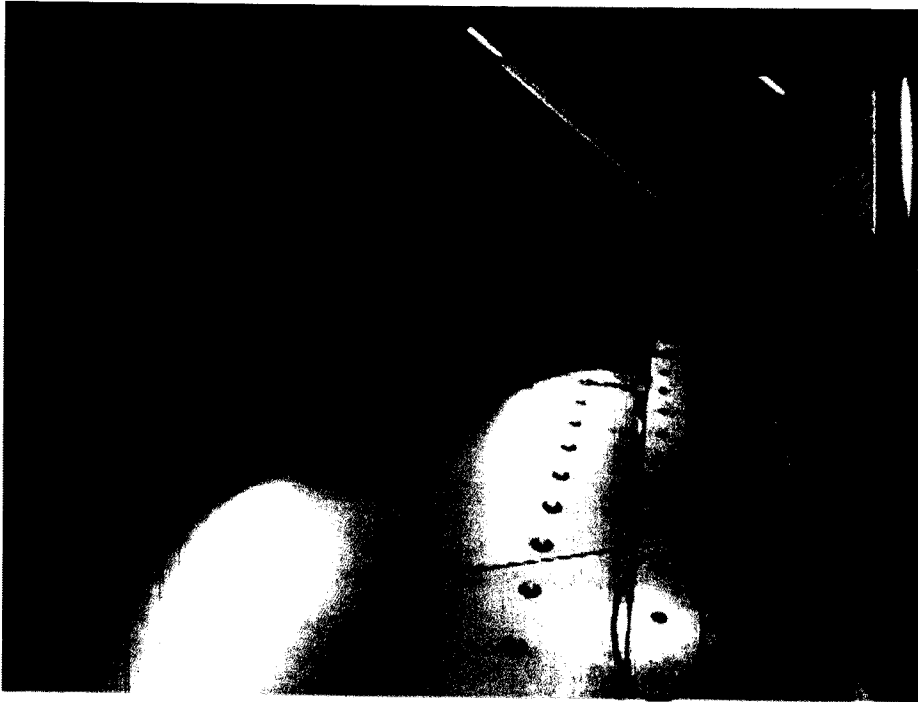
The repair and upgrade addresses inadequately chosen fastener that connects front top slope sheet (6.75" wide) and upper slope sheet. Failure of this fastener causes these two sheets to crack right under side top rail near side walls (see images).

- Front wall tarp cap
- Front top shelf extrusion
- Top slope sheet (6.75" wide)
- Upper slope sheet
- Missing fasteners

The upgrade will be performed at the front (front and rear on 40' long trailers) top shelf, top slope sheet (6.75" wide) and upper slope sheet. Top slope sheet (6.75" wide) and all of the connecting fasteners will be replaced. Front top shelf to front top rail fasteners need to be replaced. Top slope sheet will become 10.25" wide instead of 6.75" wide, this new sheet will eliminate a line of fasteners that failed on the picture above (circled). If damage already occurred, upper slope sheet will need to be replaced and slope rails checked for cracking. See below.

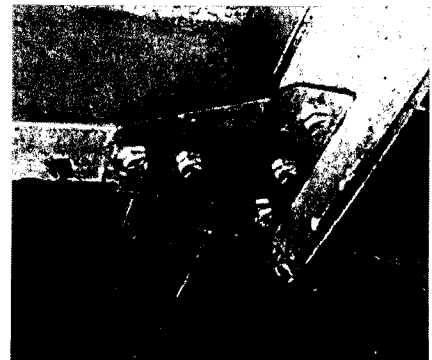
Figure A1

Repair procedure for all trailers found to have cracking or loose fasteners on the Z post (Inspection #13).

1. Remove the rivet attaching the side extrusion to the Z crossmember, where crack has occurred.
2. Place the repair clip in position over crack and install a single bolt through the Z post, side extrusion, and repair clip.
3. Ensure that the clip is properly aligned with the Z post.
  - a. Tighten the lock nut to stabilize the repair clip to the Z post.
4. Drill out the remaining holes on the repair clip using a 1/4in drill bit.
5. Install the bolts in the remaining holes and tighten all locknuts (Fig A1).
