REPAIR DOCUMENT

Ag Hopper Trailer – Liner to slope rail connection update

Repair Document #: RD-00071

Date: May 21, 2018

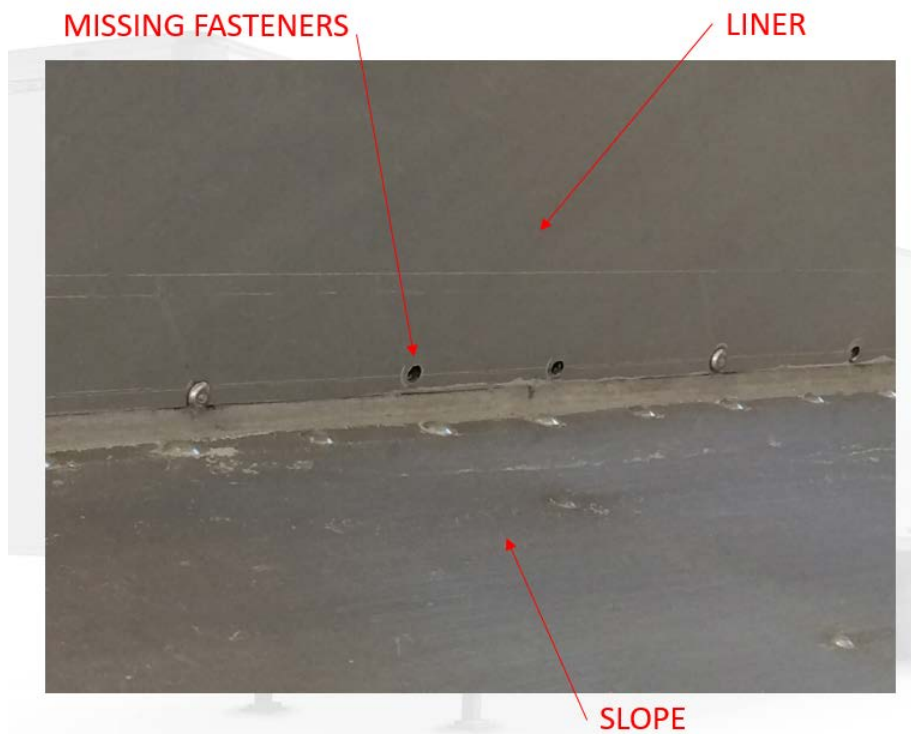
The repair addresses the issue with fasteners being pulled out due to fewer quantity than desired at liner to slope rail connection (see image).
