**TECHNICAL INSTRUCTIONS
FOR
LIMITED SERVICE CAMPAIGN FLB
CERTAIN 2010 MODEL YEAR RX 450h
OXYGEN SENSOR REPLACEMENT**

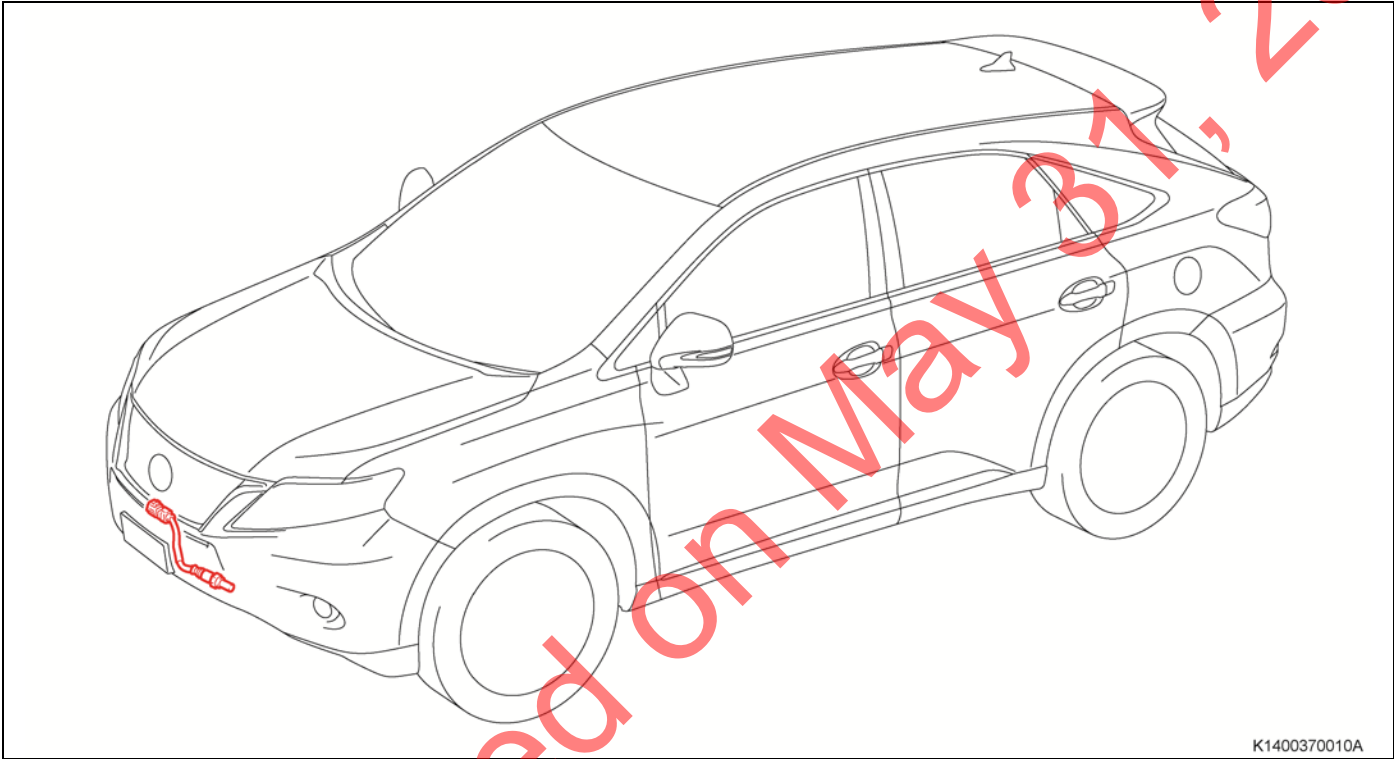
The subject vehicles are equipped with an oxygen sensor with an attached wire harness. Due to the oxygen sensor wire harness routing and engine vibration, the harness may become damaged over time. If the wire harness becomes damaged, the Check Engine warning lamp (

) may illuminate.

Lexus has designed a new oxygen sensor with a different wire harness and bracket to prevent this condition from occurring in the future.
