Subject Leak Between Engine and Transmission Bellhousing		Market USA
Service Category Drivetrain	Section CVT	
Applicability 2014 - 2018 CorollaMY Corolla

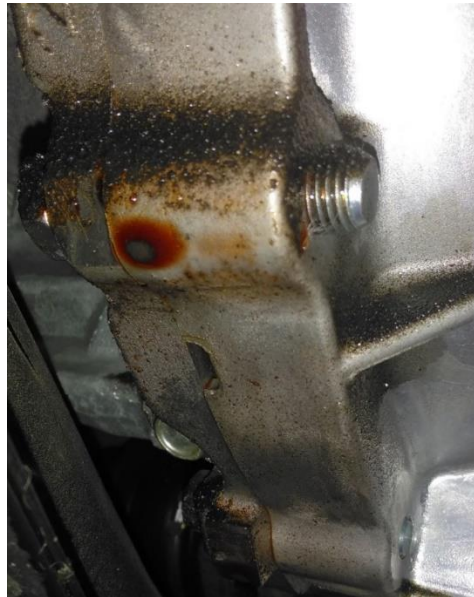
Some 2014 – 2018 model year Corollas may experience a dark red or black colored fluid leak between the engine and transmission bell housing.

Please, take pictures of the source of the leak and call TAS for repair direction.

If the leak point cannot be identified, please take pictures of the inside of the bell housing and call TAS for repair direction. If it's a weekend or holiday continue with diagnosis and repair, save all parts, photos and details, contact TAS on the next available work day and review details with TAS engineer.
