Water Entry on RH Front Floor Area

YEAR(S)	MODEL(S)	ADDITIONAL INFORMATION
2018	Camry, Camry HV

Some 2018 model year Camry and Camry plug-in hybrid vehicles may exhibit a condition where there is a musty odor or wetness in the RH front floor area of the cabin. This condition may be caused by water entry on the RH front side of the vehicle. Follow the procedure in this bulletin to address this condition.

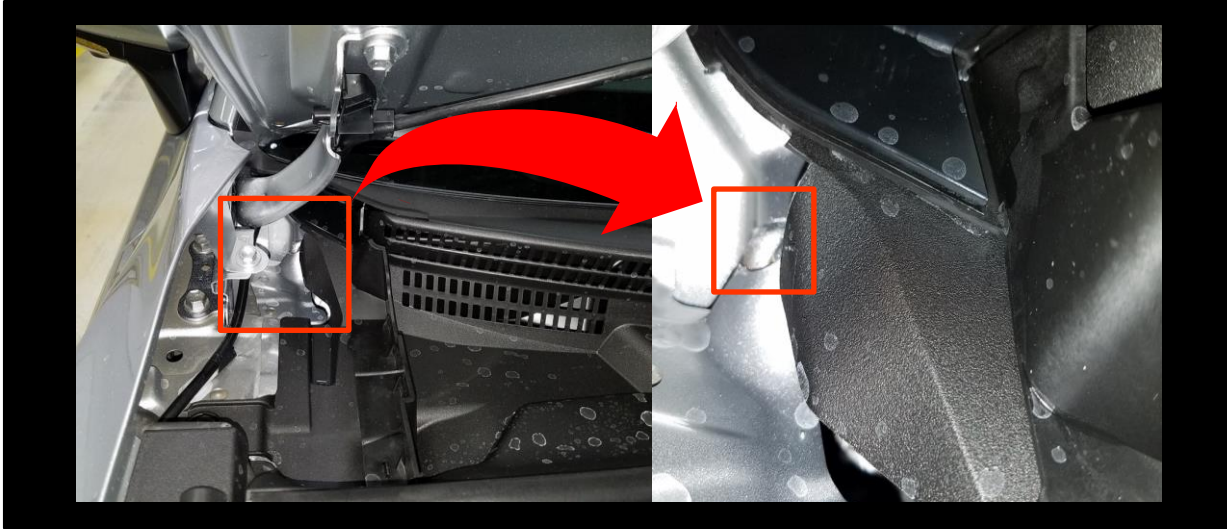
Figure 1.

Confirm missing or misapplied body sealer on the RH side of the engine compartment near the hood hinge (cowl side to member overlap/seam).

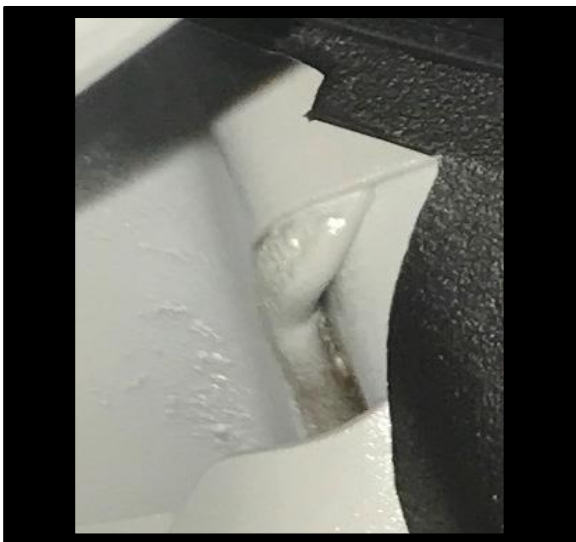
Figure 2. Body Sealer Applied Correctly on the Seam (Sealer Present Past Radius/No Gaps)

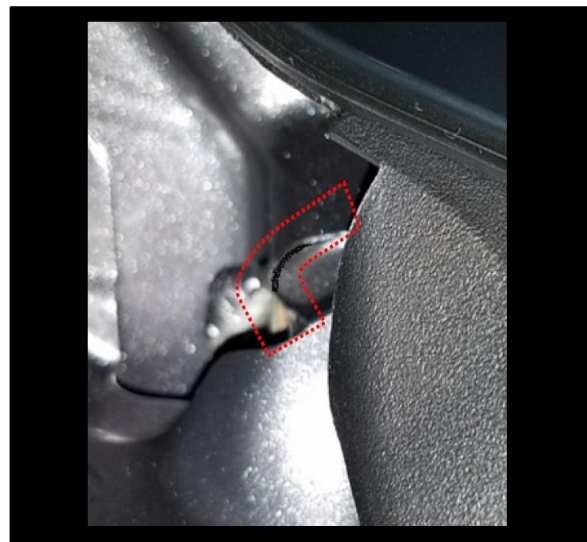
Figure 3. Body Sealer Does Not Cover the Seam

3. Fill the seam between the cowl and side member with sealer, wiping from the bottom panel to the top panel of the seam.
Ensure the sealer fills gap between panels and covers the area past the radius.
