SI B54 04 17  
Special Roofs

## CREAKING OR RATTLING NOISE FROM SUNROOF AREA

| G12 (7 Series) | | | |

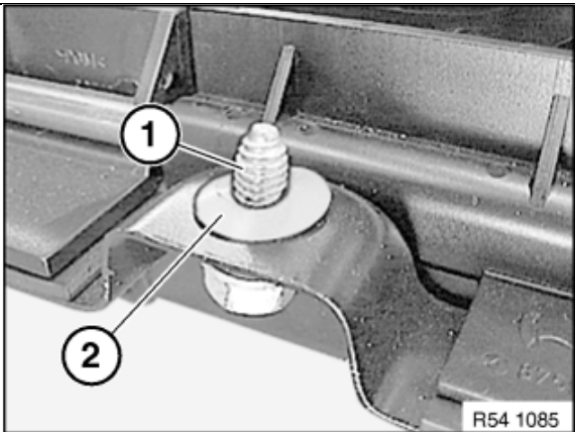
Incorrect torque applied to mounting screws during production allowing flexing/movement around the sunroof cassette/glass unit.

| | <p>3. Reinstall the glass unit into the vehicle with new screws (1), be sure to install plastic washers (2) between the sunroof cassette and threaded bushing.</p> |
| | <p>4. Coat screw threads with medium-tight thread locking adhesive (Loctite 243)</p> <p>(BMW part # 83 19 2 210 339).</p> <div data-bbox="916 1111 1011 1209" data-label="Image"> </div> <p>Note: Tighten screws, with a torque wrench, to <b>exactly 10 Nm</b>.</p> <p>Over-tightening or under-tightening may lead to a loose connection and a repeat visit.</p> |
