SI M12 02 18
Engine Electrical Systems

SERVICE ACTION: ENGINE HARNESS RE-ROUTING

F56 (MINI Cooper S)

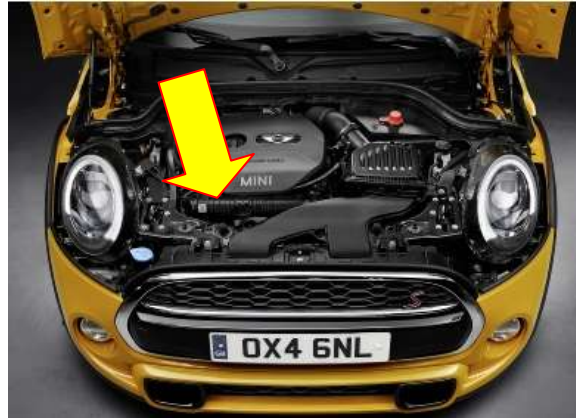
1.	A close-up photograph of engine components. Red circles with numbers 1 through 5 are overlaid on the image, with red arrows pointing to specific parts: 1 points to a corrugated tube, 2 points to a venting tube, 3 points to a cable, 4 points to another cable, and 5 points to a cable tie position.	<p>Orientation on engine</p> <ol style="list-style-type: none">1. Starter cable in Corrugated tube (B+)2. Tank venting tube (TEV)3. Cable to MAP thermostat4. Cable to A/C compressor5. Position for Cable tie <p>Position of cable tie – height of oil cooler</p>
----	--	--

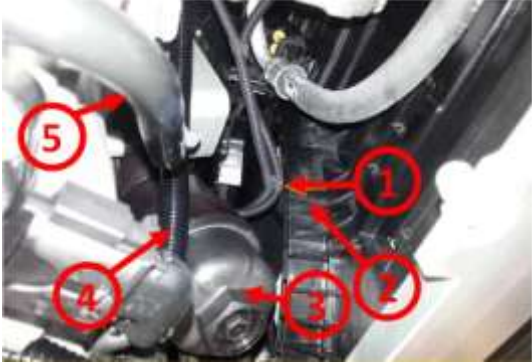
<p>Faulty wiring harness. Cable for A/C compressor and MAP thermostat reach into radiator fan area.</p> <ol style="list-style-type: none">1. Harness for Map thermostat and A/C compressor.2. Fan shroud3. Oil filter4. B+ cable for starter5. Tank vent line (TEV)
4.
