H111 UPS3918-2BNAS1

TECHNICAL BULLETIN

303-03B / -03C: Engine Cooling

Update Prior to Sale: Auxiliary Water Pump Inlet Hose Incorrectly Routed

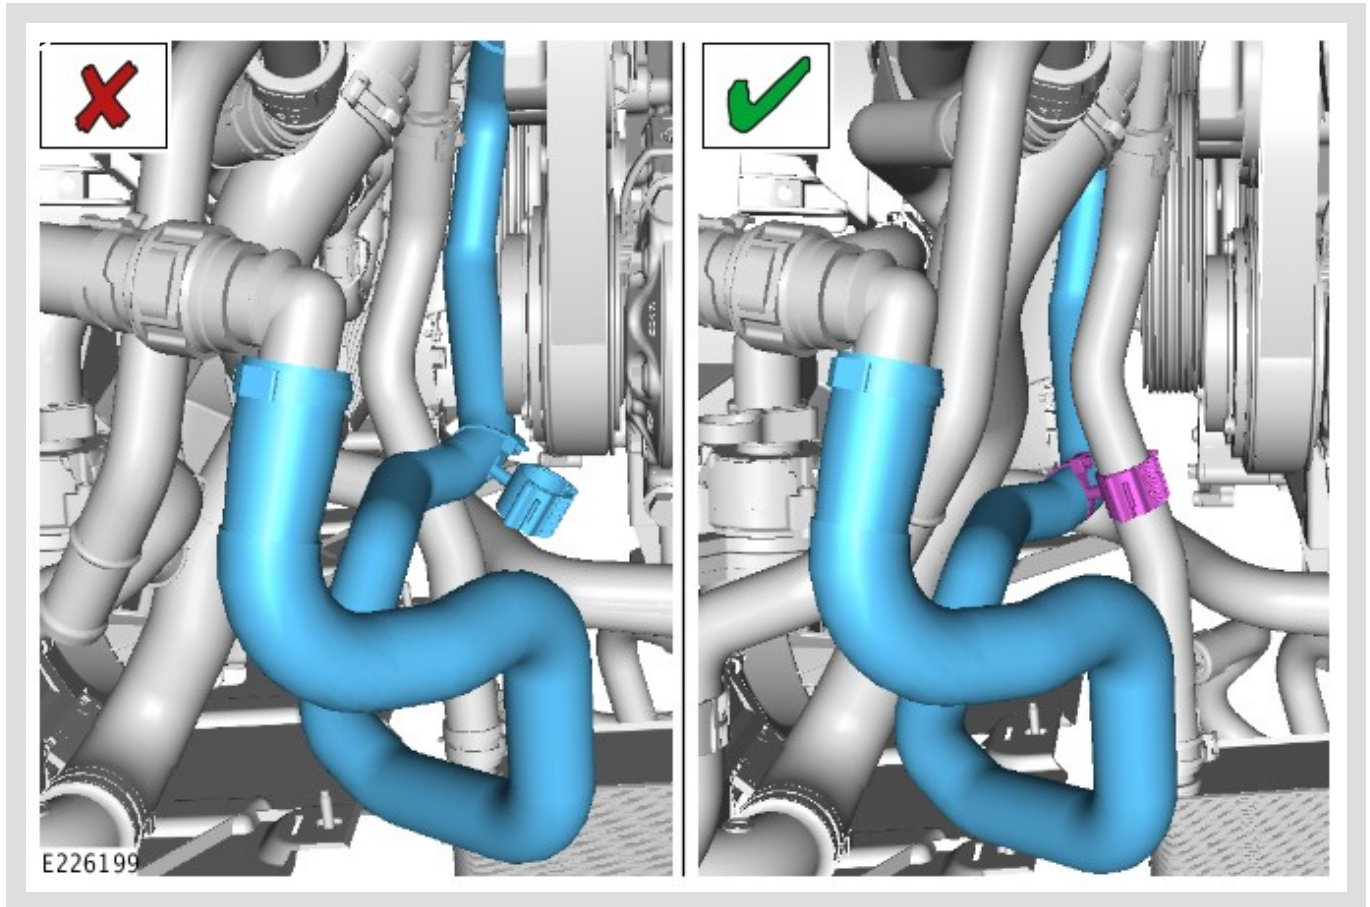
3

Inspect the auxiliary water pump inlet hose.

- If the auxiliary water pump inlet hose **IS** installed correctly (✓), go to Step 8.
- If the auxiliary water pump inlet hose **IS NOT** installed correctly (✗) and the hose **IS NOT** damaged, go to Step 4.
- If the auxiliary water pump inlet hose **IS NOT** installed correctly (✗) and the hose **IS** damaged, go to the Workshop Procedure below.

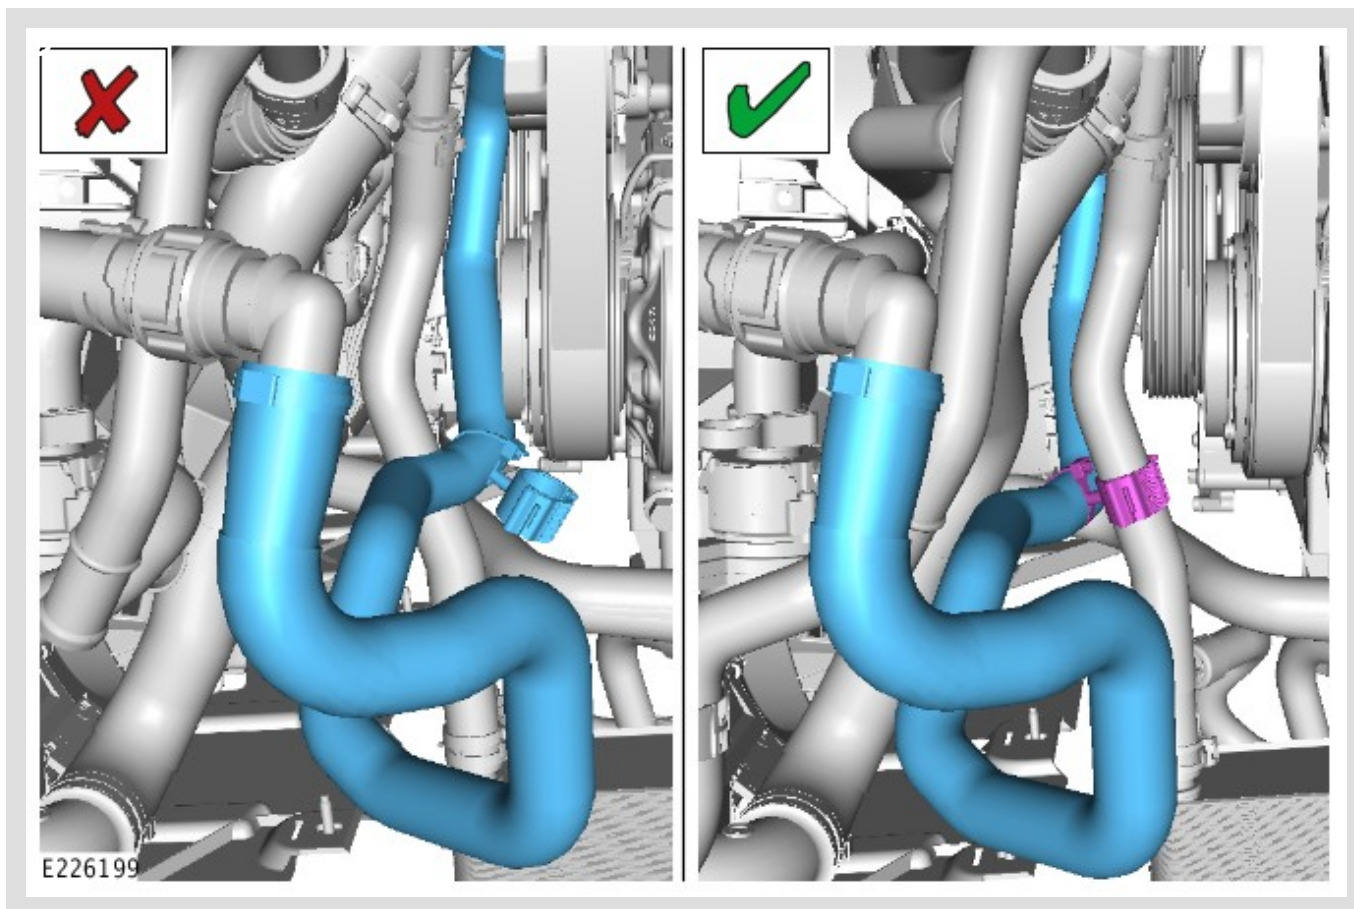
8

Make sure the hose is routed correctly (✓) as shown.

Reverse Steps 5-7 to install the new auxiliary water pump inlet hose.
