# SERVICE CAMPAIGN BULLETIN

NTB18-044

## VOLUNTARY EMISSIONS SERVICE CAMPAIGN 2018 SENTRA SR AND NISMO; ECM REPROGRAMMING

**CAMPAIGN ID #:** R1805  
**APPLIED VEHICLES:** 2018 Sentra SR (B17)  
2018 Sentra Nismo (B17)

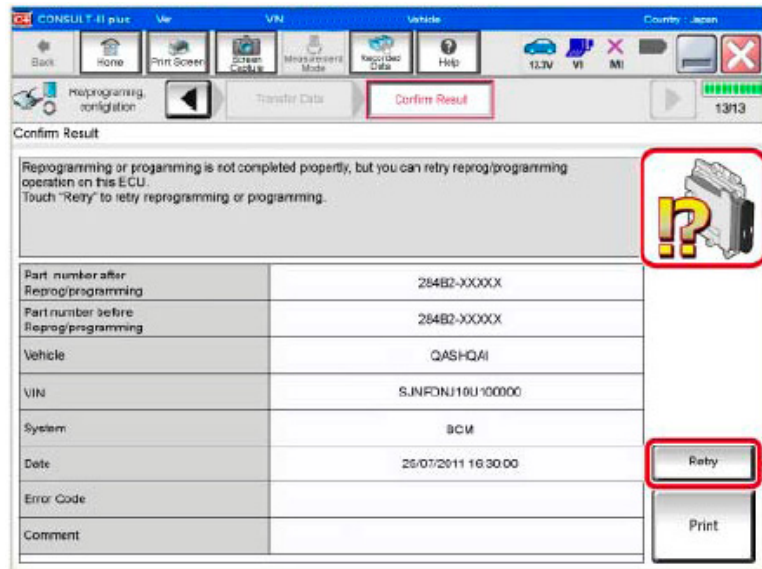
Figure 6

If reprogramming does not complete and the “!?” icon displays as shown in Figure 6:

- Check battery voltage (12.0–15.5 V).
- Ignition is ON, engine OFF.
- External Bluetooth® devices are OFF.
- All electrical loads are OFF.
- **Select retry and follow the on screen instructions.**
- “Retry” may not go through on first attempt and can be selected more than once.

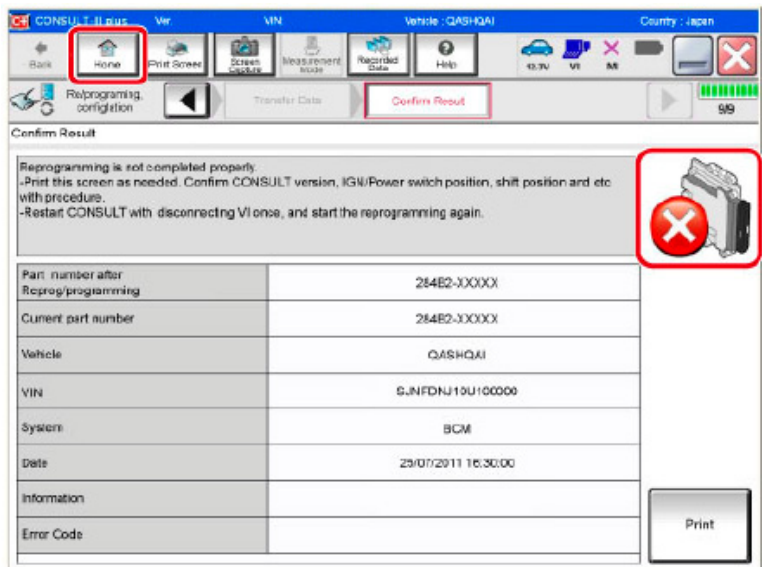
Figure 7

If reprogramming does not complete and the “X” icon displays as shown in Figure 7:

- Check battery voltage (12.0 – 15.5 V).
- CONSULT A/C adapter is plugged in.
- Ignition is ON, engine OFF.
- Transmission is in Park.
- All C-III plus / VI cables are securely connected.
- All C-III plus updates are installed.
- **Select Home, and restart the reprogram procedure from the beginning.**
