First Release

2018-06-06

## AC COMPRESSOR DISCHARGE HOSE REPLACEMENT

Prevost vehicles

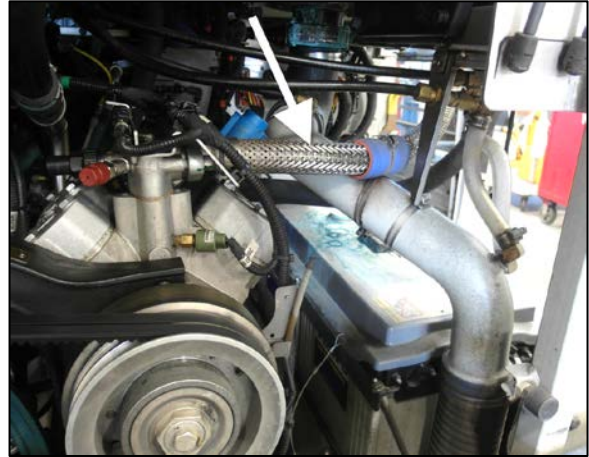
Figure 5

10. Locate the existing AC compressor discharge hose into the engine compartment (Figure 5).
