Special Bulletin

SP18-24

BELLEVILLE WASHER ADDITION ON SLIDE-OUT

Prevost vehicles

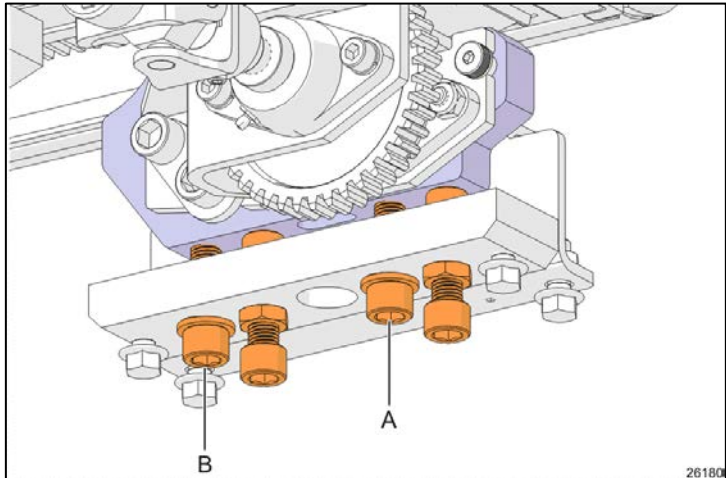
Figure 4: Leveling screws

On the vehicles affected by this bulletin, add Belleville washers on the leveling screws of the front right slide-out.

4. Remove screw **A** (Figure 4).
5. Add missing washer 5002082.
Tighten to **55-65 lb-ft (75-88 Nm)**
6. Remove screw **B** (Figure 4).
7. Add missing washer 5002082.
Tighten to **55-65 lb-ft (75-88 Nm)**
8. Re-install access hatch and seat.
