## RECEIVER TANK BRACKET IMPROVEMENT

Prevost vehicles

On the vehicles affected by this bulletin, the condenser compartment wall may present fatigue cracks on or near the A/C receiver tank support. Follow these instructions to repair and improve the support.

| NOTICE TO SERVICE CENTERS | | |
|---|---|---|
| X3-45 Commuter<br>Model Year : 2014 - 2016 | From 2PCG33495EC735590 up to<br>4RKG33491G9737299 incl. | From 2490 up to<br>2789, incl. |

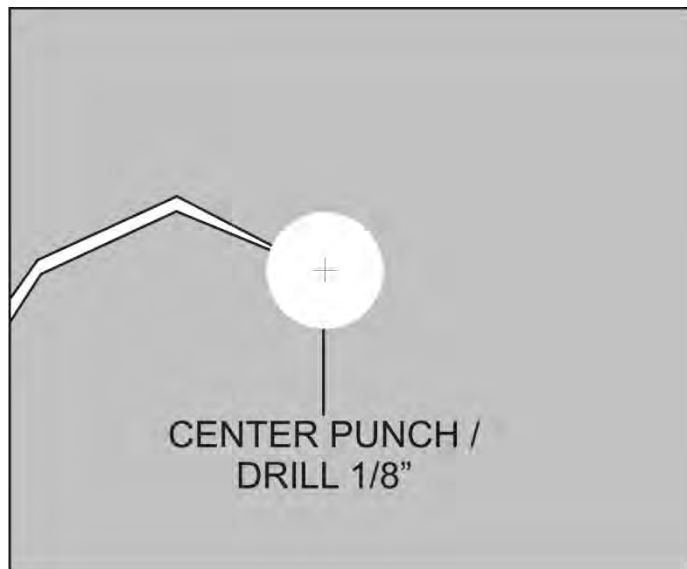
Figure 11: Crack, less than 1/4"

22. Locate any remaining cracks on the wall  
SHORT CRACKS (LESS THAN 1/4")
23. Find the very end of the crack. Use a punch to locate precisely the relief hole.
24. Drill a 1/8" diameter relief hole. (Figure 12)

25. Repair cracks with weld. Refer to APPENDIX C
