# Special Bulletin

# SP18-304 A

## SLIDING DOOR ADJUSTMENT AND HARDWARE REPLACEMENT

Prevost vehicles

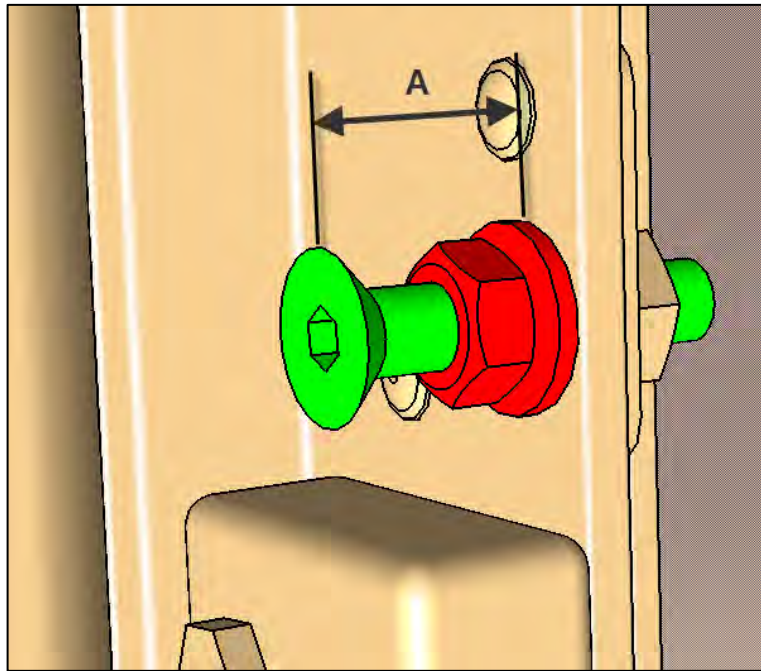
Figure 18

18. Check dimension "A" on proximity switch target.

Note: Target screw should be a countersunk socket head cap screw.

If target is a hex head screw, Inform the service manager and refer to bulletin SP15-343 for replacement instructions.

Hand tighten and adjust to  **$13/16" \pm 1/16"$**  (21  $\pm$  2mm) (A) (Figure 18)

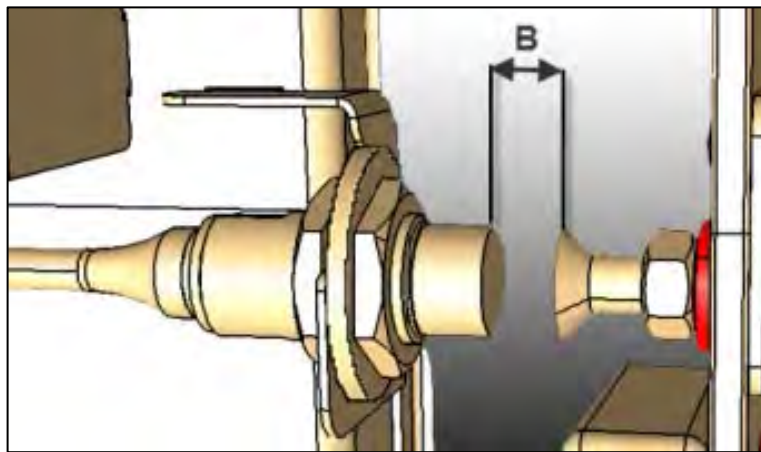
Figure 19

19. Check gap between proximity switch and cap screw to  **$5/16" \pm 1/32"$**  (8mm  $\pm$  1mm) (B) (Figure 19)

20. If adjustment was required:

Hold cap screw and tighten nut to **16 lb-ft** using a crowfoot adapter on the torque wrench. Re-Apply torque seal mark.

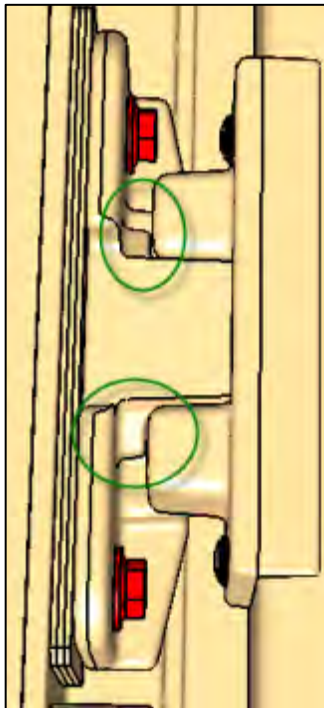
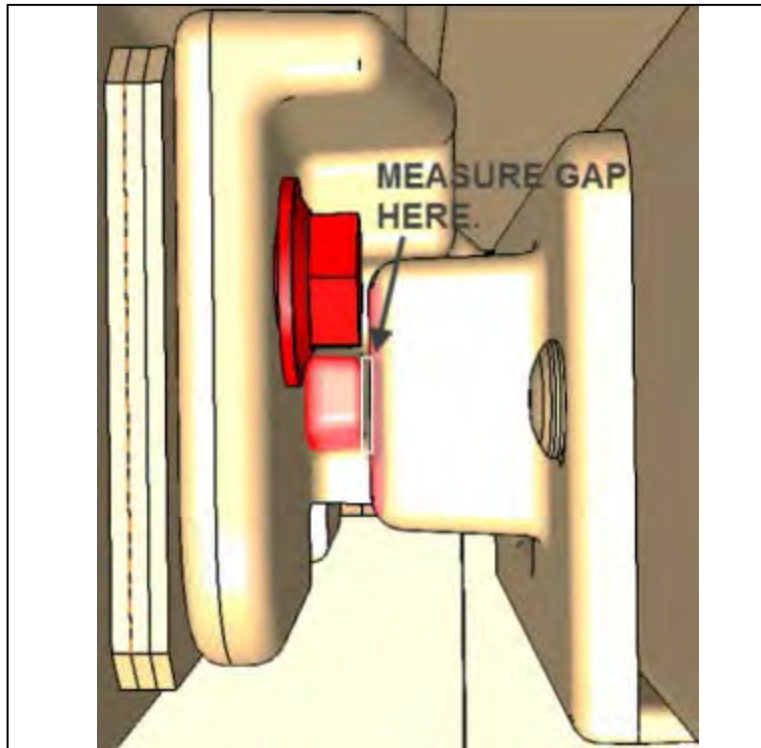
Looking at the fingers from the top. Use feeler gages to assess the gap between the small boss on the finger and the receptacle face

Use a feeler gage to confirm gap

Min **1/64"** (0.5mm)

Max **3/64"** (1.1mm)

If gap is not within the above values, add or remove shims as required.

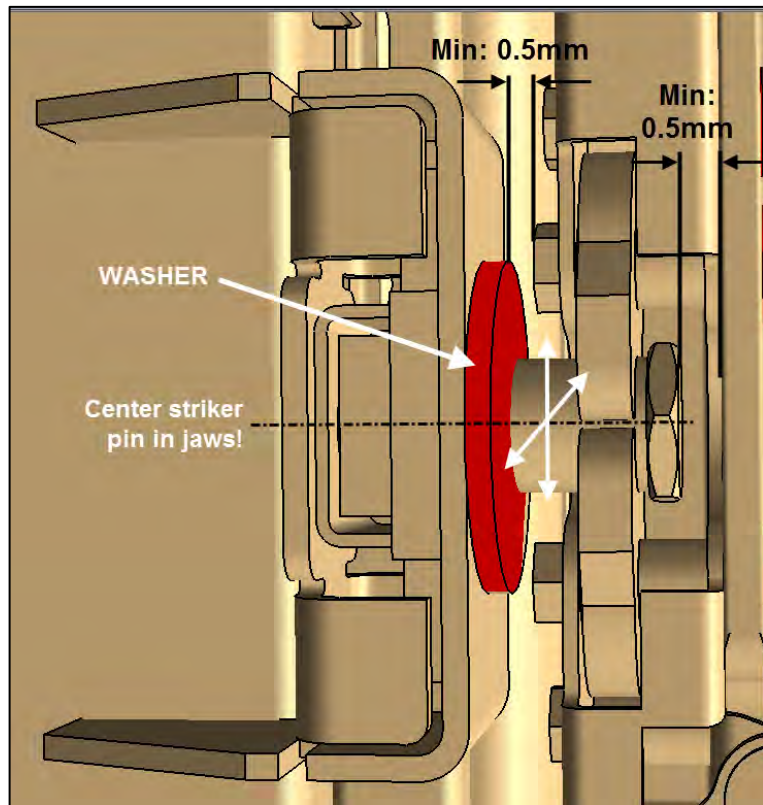
Figure 28

30. Check gaps as shown on Figure 28. Min **1/64"** (0.5mm)

*If gaps are smaller, inform your Prevost Regional Service Manager (RSM).*

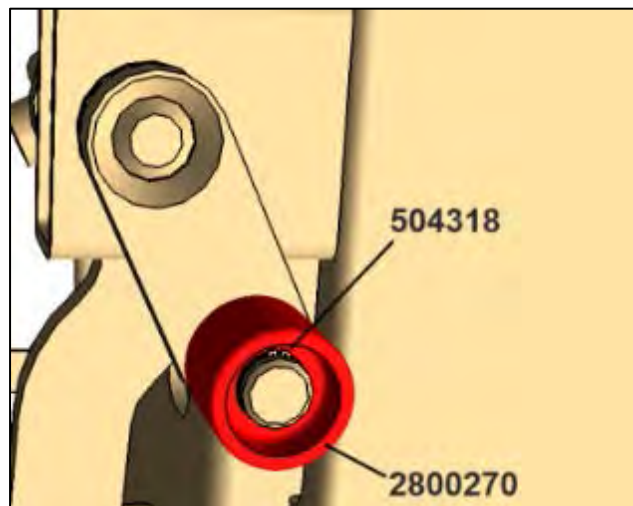
Figure 29

31. Inspect roller condition.

Rollers should be free of flats, and have a smooth surface finish.

Replace the roller as required.

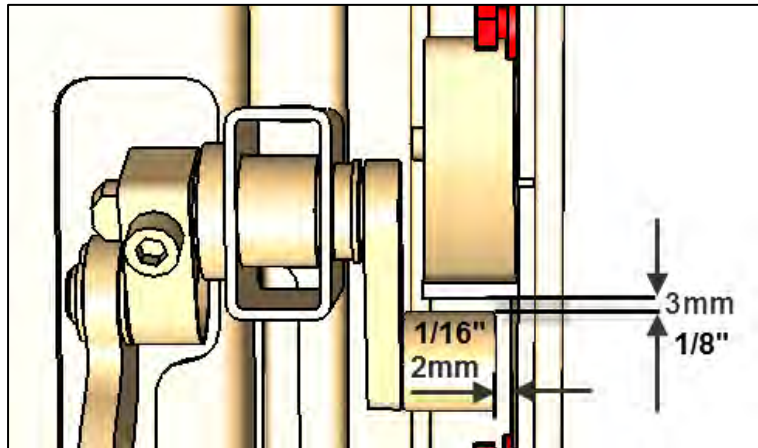
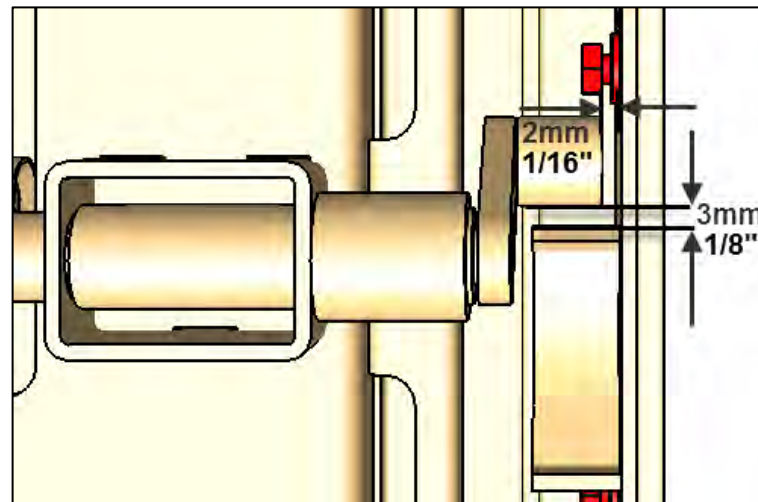
32. Distance between *roller and plate* with door closed should be **1/8"** (3mm).

33. Gap between *roller end and door* should be minimum **1/16"** (2mm).

Adjust as required on upper and lower catch plate.

Trim roller end as required to get closer the target value.

34. If adjustment was required, tighten the catch plate screws to **7 lb-ft**

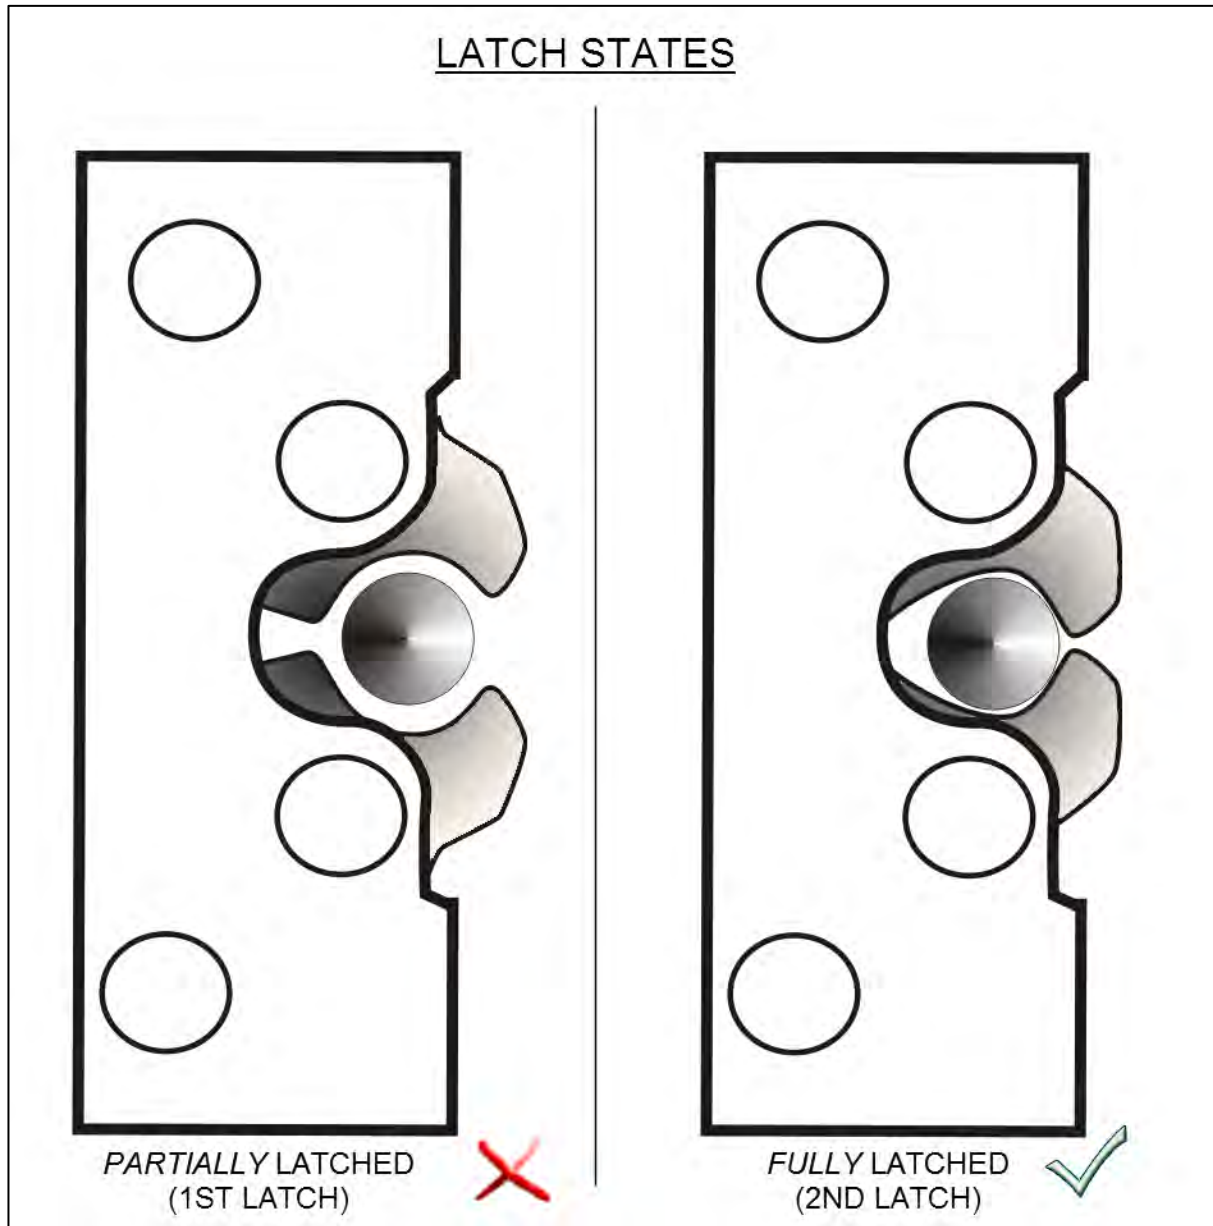
Figure 33

39. The second latch state (Figure 33) should be applied by the lock assist mechanism alone, *without any operator intervention each time the door is closed.* If door fails this test, return to step 34.

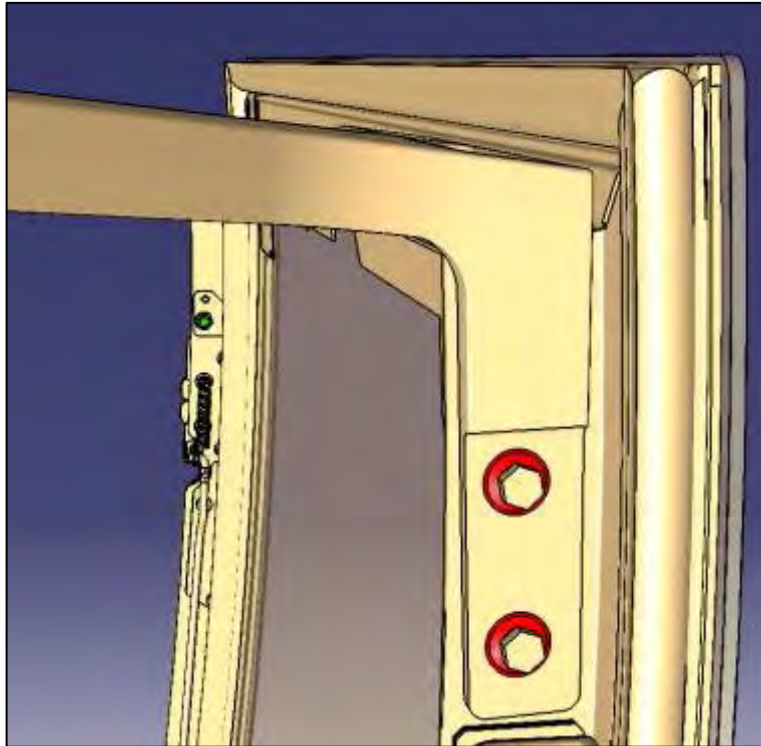
Figure 34

On the door upper arm vertical face, inspect torque seal. (Figure 34)

41. If broken, tighten to **16lb-ft**

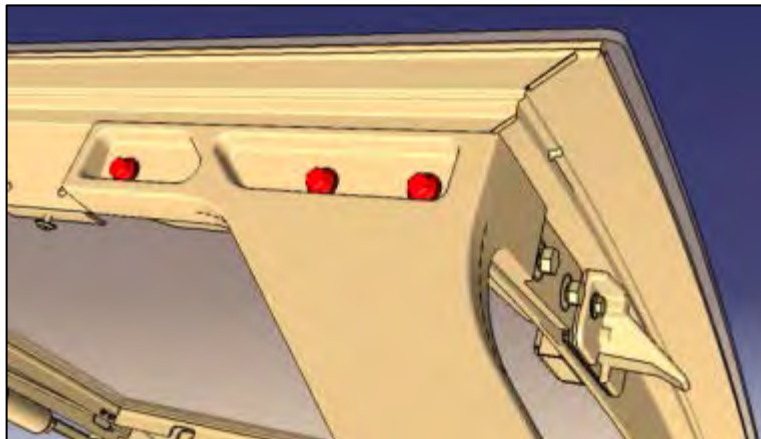
Figure 35

43. On the door upper arm top, inspect torque seal. (Figure 35)

44. If broken, tighten to **7 lb-ft**

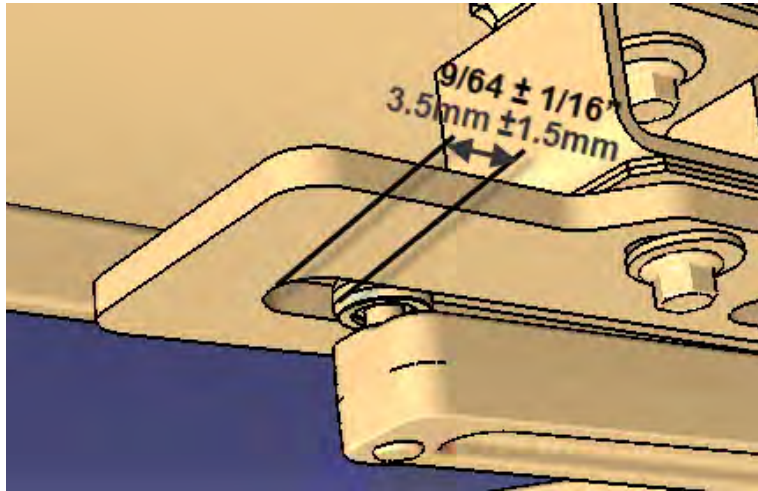
Figure 45

**INSPECTION #1:** Distance between the end of both fork slots and roller should be:

**$9/64 \pm 1/16$ "**

**$3.5 \pm 1.5\text{mm}$**

69.Perform any required adjustment per *INSPECTION* instructions below, tighten fork screws to **32 lb-ft**.  
Add torque seal mark.

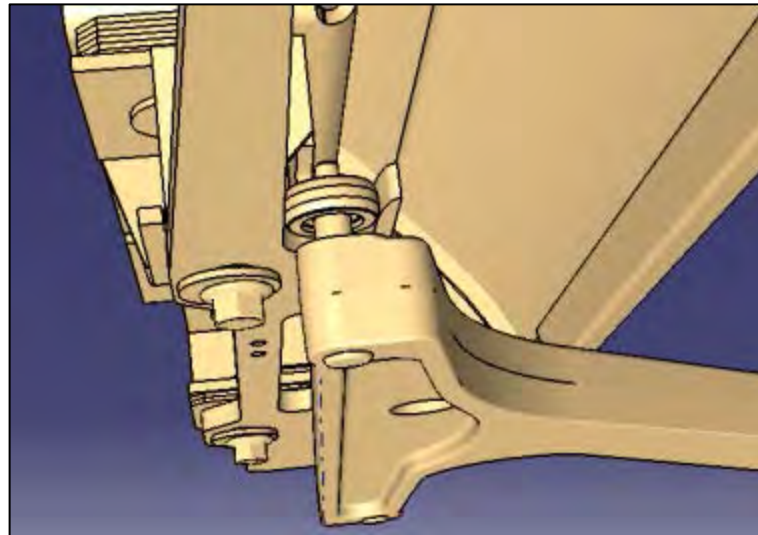
Figure 46

**INSPECTION #2:** Move the door back and forth at the point of engagement of the roller in the fork. The roller should be properly centered in the slot opening without striking on either side of the fork. (Figure 46)

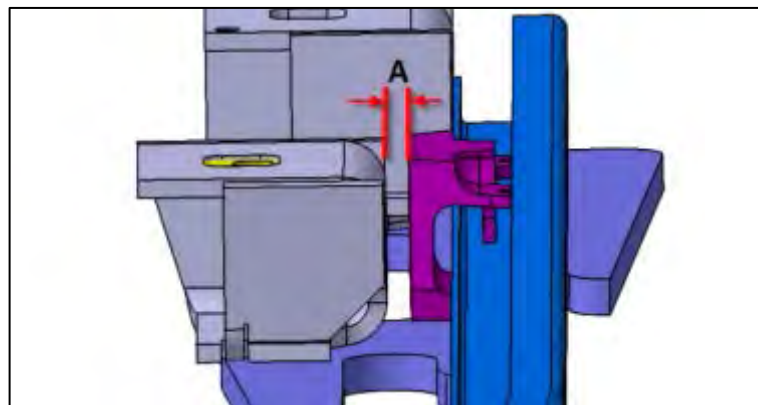
Figure 47

**INSPECTION #3:** Minimum gap between the aft fork support and wheel carrier should be  $1/32$ " (1mm) (dimension A)

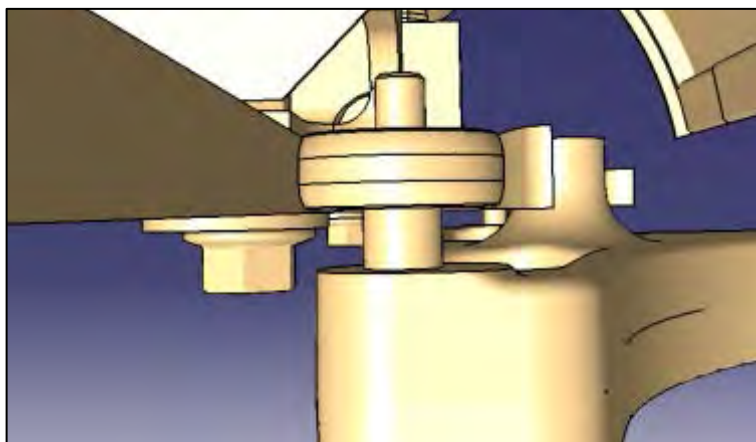
Figure 48

*INSPECTION #4:* Check the roller **vertically** to make sure it is centered in the fork slot surface. (Figure 48)

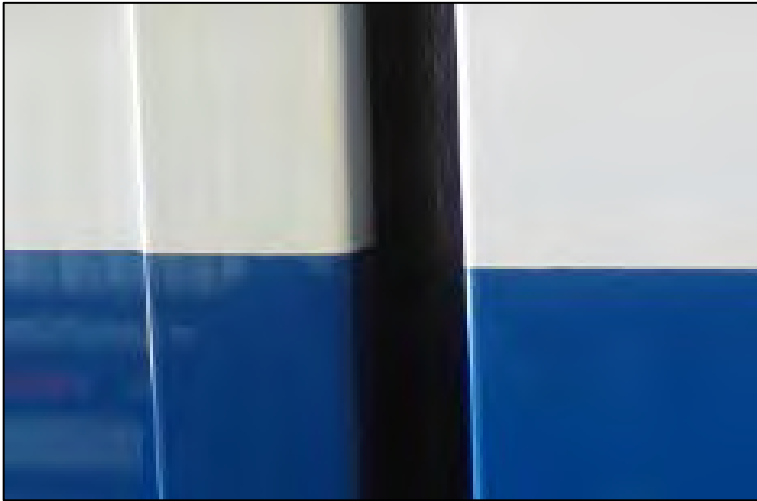
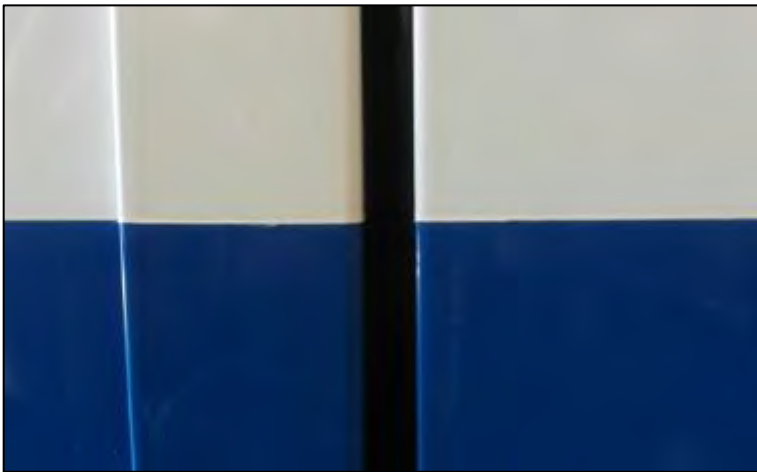
If the door is adjusted properly, you should feel a slight upward movement when closing.

If there is no upward movement, "door fingers" will need to be adjusted vertically. Contact your RSM.

71. To see the movement, stare at the paint line. As the door approaches the point of contact between the fingers and the receptacles you can see the paint line on the door move up slightly. (Figure 49 & Figure 50)

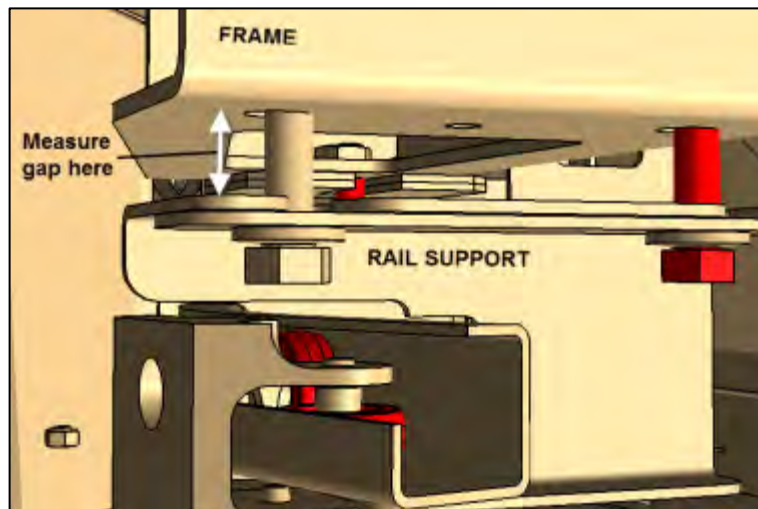
Figure 54

76. Measure the gap between the rail support and frame. (Figure 54)

Calculate the required number of #286421 shims equivalent to the gap value minus 5/32". See calculation example below.
