# Technical Service Bulletin

| <b>Technical Service Bulletin:</b><br>TSB180081 | <b>Released Date:</b> 13-Jun-2018 |
| <b>HGJBB Under-Torqued Bolts on the Stator Backing Plate</b> | |

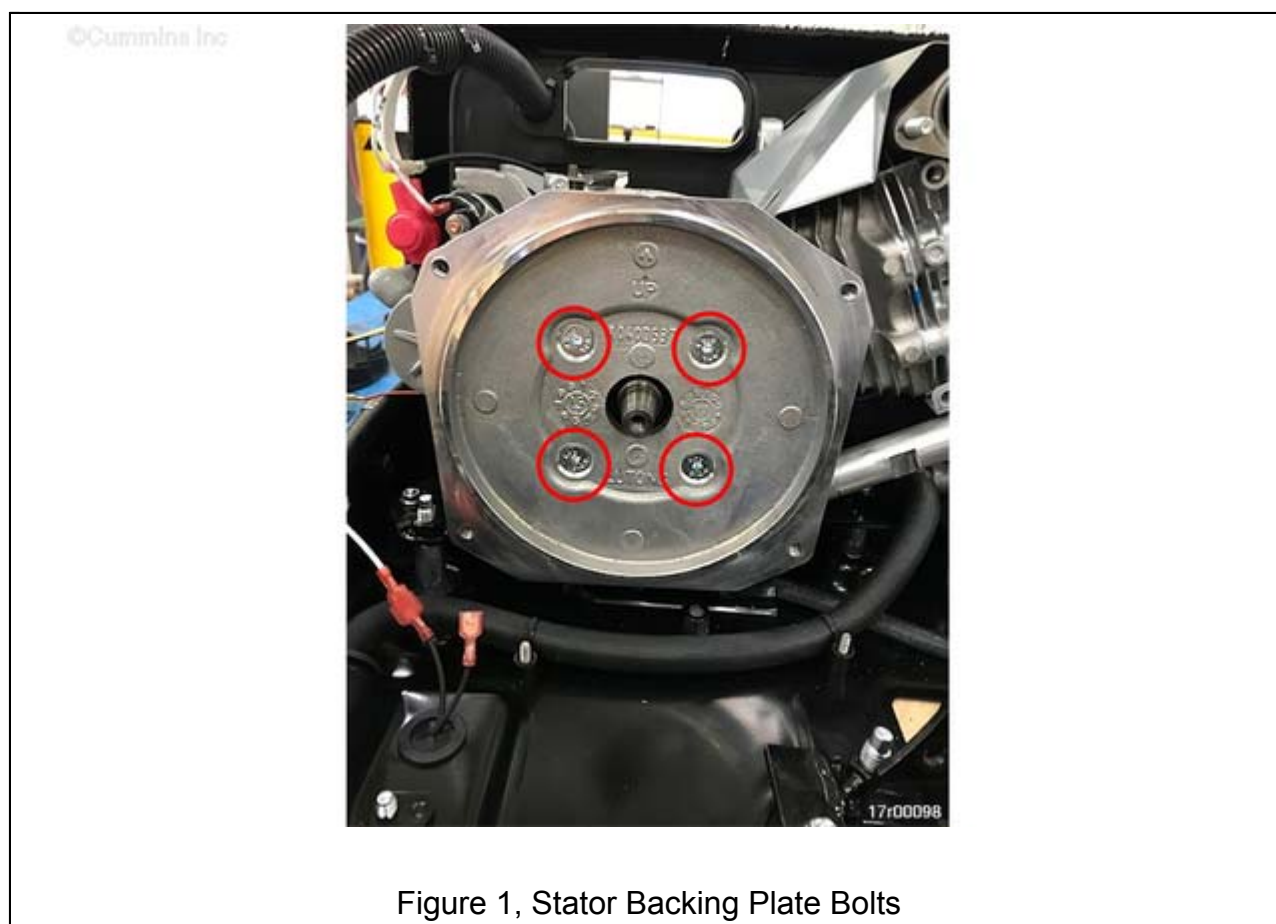
- The generator may not show any physical symptoms initially. However, if the bolts are left under-torqued, they may come free and cause damage to the alternator, potentially resulting in a generator failure.

- A defect with a DC torque tool used on the production line caused a limited number of stator backing plate bolts to be under-torqued. The issue was not initially detected, and a limited number of HGJBB generators were shipped from the factory with these bolts potentially being under-torqued. The list of suspect serial numbers can be found at the end of this bulletin.

1. If installed, remove the generator from the coach
2. Follow the Alternator Disassembly steps in section 5.2.2.1 of the HGJBB service manual (A031C173)
3. Once the alternator has been removed, use a torque wrench to tighten the four bolts (See Figure 1 below, circled in red) on the stator backing plate to 23 N•m
4. After the four bolts have been torqued to the correct value, follow the Alternator Assembly steps in section 5.2.2.2 of the HGJBB service manual (A031C173)

**Note :** If any of the bolts have come free, it may be necessary to replace the alternator. Inspect the alternator for damage, and follow the troubleshooting steps in the service manual if necessary.
