GROUP Body	MODEL 2015MY~ K900 (KH) 2016MY~ Optima (JFa/JF) 2018MY~ Stinger (CK)
	NUMBER PS299 (Rev 2, 07/30/2018)	DATE March 2014

SUBJECT: CORRECT PROCEDURE FOR RAISING WINDSHIELD WIPERS

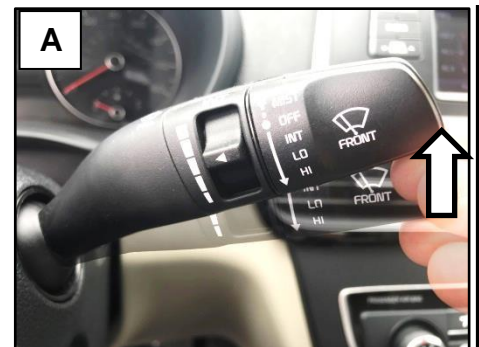
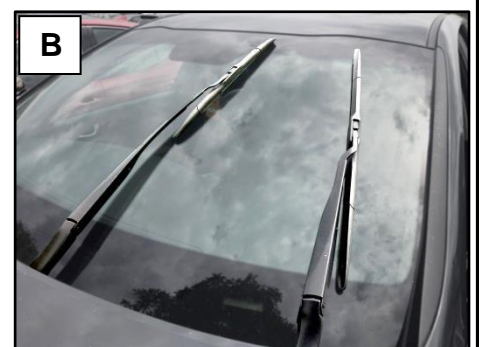
When servicing the windshield wipers on 2015MY~ K900 (KH), 2016MY~ Optima (JFa/JF), and 2018MY~ Stinger (CK) vehicles during PDI, make sure to use the procedure outlined below to raise the wiper arms to the fully vertical position in order to **avoid damaging the paint on the rear edge of the hood**. It is important to note that the wipers on these vehicles are recessed under the hood to provide better appearance and reduced wind noise characteristics. This procedure applies to both key start and SMK type ignition systems.

1. Turn the vehicle ignition ON with the engine OFF and then turn the ignition OFF.
2. Within three (3) seconds after turning the vehicle ignition OFF, raise the wiper blade control stalk and hold it for more than two (2) seconds (A).
3. The wiper arms will move upward and stop in the fully vertical position (B). The wiper arms may now be moved away from the windshield for any needed PDI process or service procedures.
4. Once finished servicing the wipers, turn the vehicle ignition ON with the engine OFF. Then, move the wiper blade control stalk up to return the wipers to the “parked” position.
5. Finally, turn the vehicle ignition to the OFF position.
