GROUP Electrical	MODEL See List Below
	NUMBER PS464 (Rev 2, 07/30/2018)	DATE September 2016

SUBJECT: NO COMMUNICATION WITH BLIND SPOT DETECTION AFTER COLLISION REPAIRS

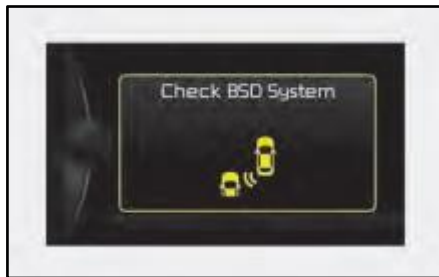
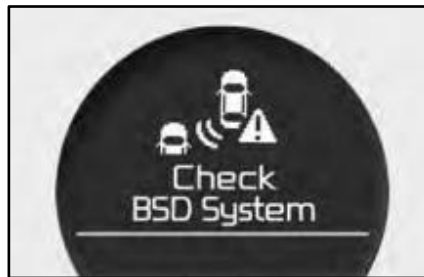
This Pitstop provides information relating to the vehicles listed below with Blind Spot Detection (BSD), which may exhibit a “Check BSD System” message and no communication with the BSD system after collision repairs. This concern is commonly caused by the rear bumper harness installed backwards.

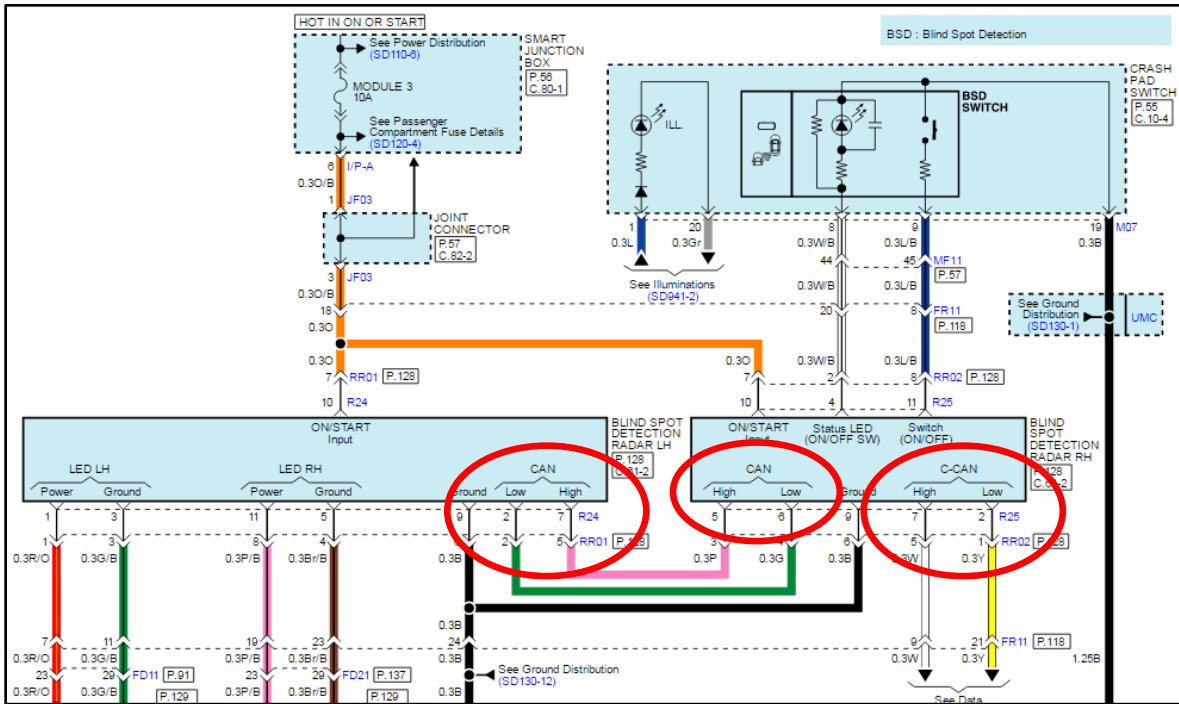
The master BSD module, located at the right side of the rear bumper, is the only BSD module that communicates on the C-CAN. The slave module (left side of bumper) communicates to the master module via local network CAN. The master and slave module connectors are physically identical and may be mistakenly swapped.

To confirm correct installation of the harness, verify the pin location is correct for the left or right side module, which can be found on KGIS. See diagram on page 2.
