GROUP CHA	MODEL 2018MY Niro (DE PHEV)
	NUMBER 089 (Rev 2, 07/16/2018)	DATE April 2018
TECHNICAL SERVICE BULLETIN		
SUBJECT: SERVICE ACTION: REAR LOWER CONTROL ARM REPLACEMENT (SA338)

This bulletin provides the procedure to replace the rear lower control arms and/or damaged wheel(s) on some 2018MY Niro (DE PHEV) vehicles, produced from September 26, 2017 through January 22, 2018, which may experience a noise from the rear lower control arm rubbing against the inner part of the wheel rim. Kia is requesting the completion of this Service Action on all affected vehicles including dealer stock, prior to delivery. Before conducting the procedure, verify that the vehicle is included in the list of affected VINs.

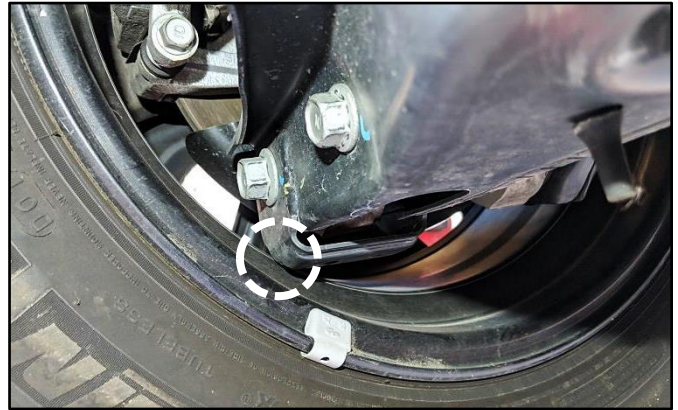
1. Lift vehicle on hoist and remove the rear wheels. Inspect the inner wheel rim area on both wheels for possible damage from rubbing against the Lower Control Arm (LCA) in the area shown. If no damage is found from the LCA rubbing against the wheels, set the wheels aside to reinstall after completing this procedure.

If wheel damage is present, then a replacement wheel(s) will be required prior to completing this bulletin. To ensure complete customer satisfaction, any noticeable sign of rubbing to wheel(s) from the LCA is cause for replacement of the wheel(s).
