Product Emission Recall

17089 NOx Position 1 Sensor Replacement

Reference Number: N151645630

Release Date: May 2018
Revision: 01

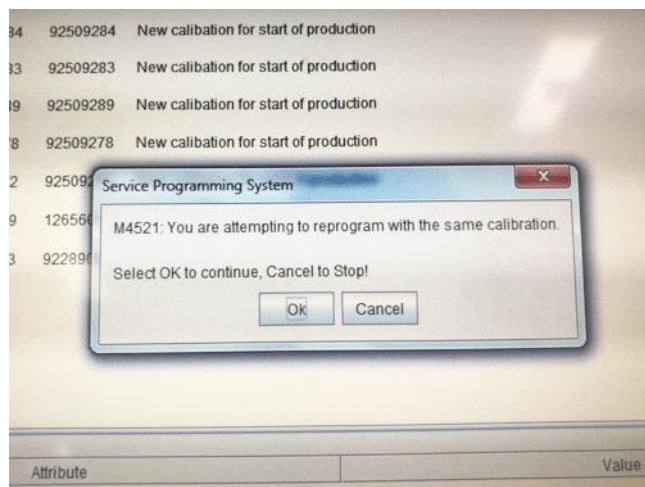
5045242

Note: If the Same Calibration/Software Warning is noted on the SPS controller screen, select “OK” and continue programming.

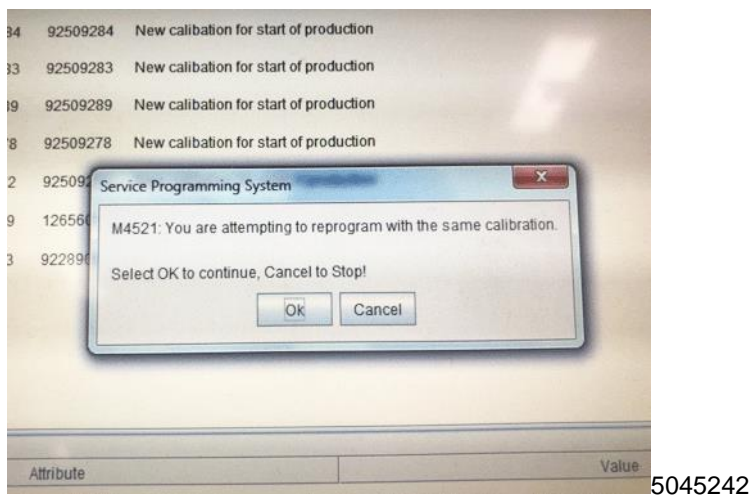
Note: If the Same Calibration/Software Warning is noted on the SPS controller screen, select “OK” and continue programming.
