# Service Update

## 18175 Incorrect Bolt for Brake Pedal Assembly

Reference Number: N182167170

Models: 2018 – 2019 Buick LaCrosse

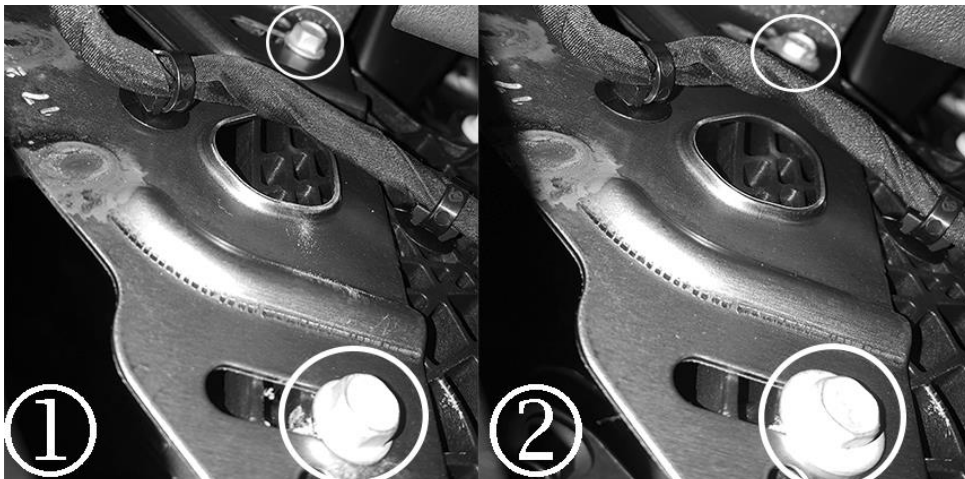
5072386

**Caution:** The heater core is very near the two bolts in question, use caution to avoid burning yourself if the vehicle is at operating temperature.

1. Remove the left side instrument panel lower trim panel insulator. Refer to *Instrument Panel Lower Trim Panel Insulator Replacement - Left Side* in SI.

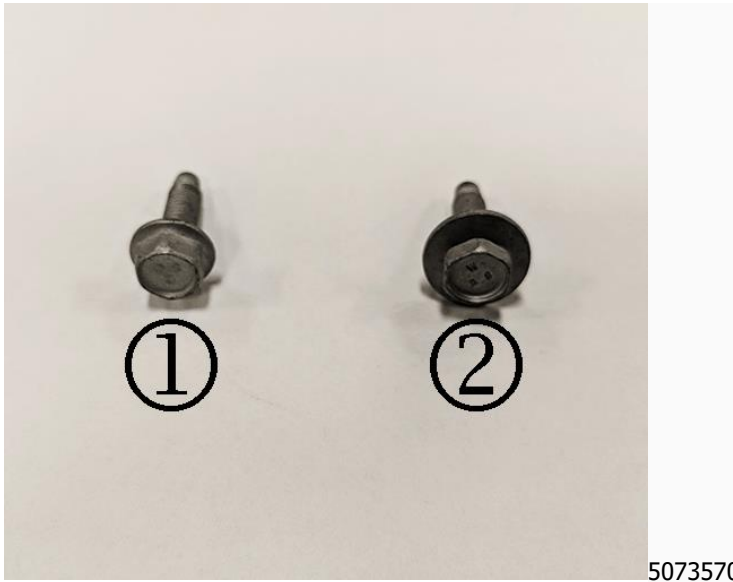
<b>Condition</b>	Certain 2018 and 2019 model year Buick LaCrosse vehicles may have the incorrect bolt installed on the brake pedal assembly box.
<b>Correction</b>	Inspect and replace bolts.

2. Inspect the two bolts shown on the brake pedal assembly. If there is no captured washer on the bolts (1), proceed to step 3. If the bolts already have a captured washer (2), proceed to step 4.
3. Replace the bolts one at a time. Torque the new bolts to 9N-m (80 Lb-in).
4. Reinstall the left side instrument panel lower trim panel insulator. Refer to *Instrument Panel Lower Trim Panel Insulator Replacement - Left Side* in SI.
