Preliminary Information

PIT5281A Wind Whistle Noise At Highway Speed

Brand:	Model:	Model Years:	VIN:		Engine:	Transmissions:
			from	to		
Chevrolet	Silverado 2500/3500 HD	2015 - 2016	All	All	All	All

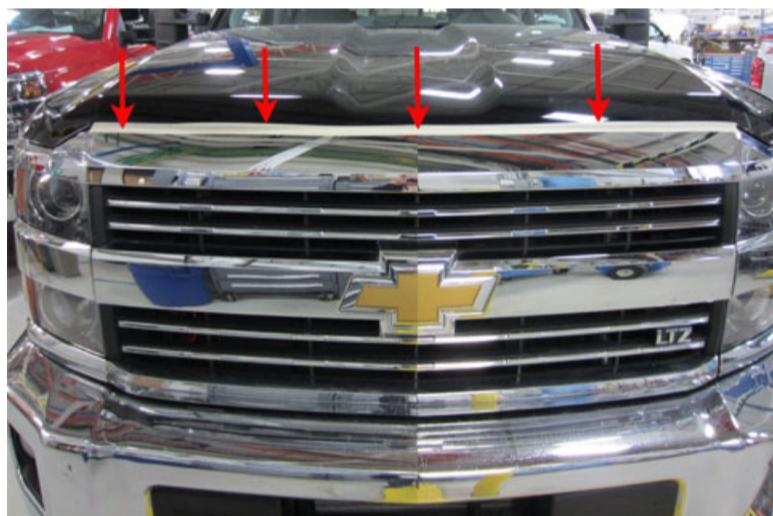
This may be caused by a gap between the front compartment sight shield and the top of the grille.

To root cause this concern, place a piece of tape from the front of the hood to the top of the chrome on the grille. Apply tape all the way from the left hand side to the right hand side, as shown below

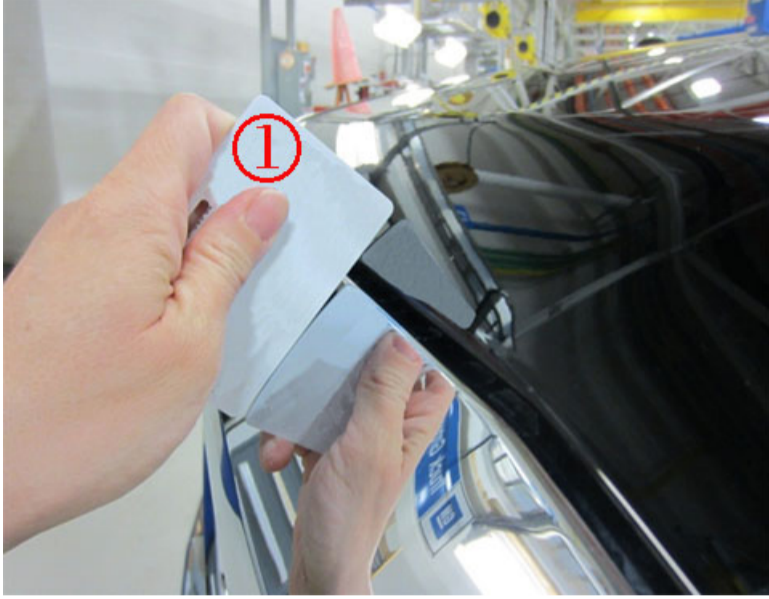
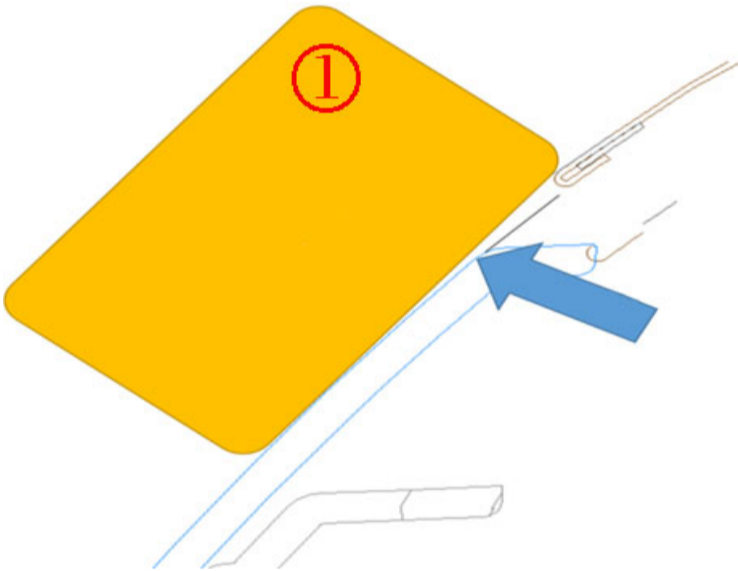
2. Grille adjustment procedure:

Check to see if the chrome portion of the grille is sub-flush to the hood, by using a flat edge and placing it on the chrome of the grille. Then slide it up until it reaches the tip of the hood. Perform this check in several spots from left to right. The grille position is correct if the flat edge (1) has to be raised up to sit on the hood as shown in the diagrams and picture below. If the flat edge (1) does not touch the hood, the grille is proud of the hood and will need to be adjusted per the following procedure.

Adjust the grille to hood relationship by first removing the sight shield. Loosen the four mounting bolts of the grille, push it rearward, and retighten the bolts. Remeasure the grille flushness. If the grille is still not sub-flush as shown above, cut off the center two fore/aft locating tabs near the 10mm bolts, as shown below
