Bulletin No.: PIP5571  
Published date: 06/7/2018

### PIP5571 MIL / SES Lamp On After Engine Repairs, P0016 Set and Rough Idle

Brand:	Model:	Model Years:	VIN:		Engine:	Transmissions:
			from	to		
Chevrolet	Colorado	2017 - 2018	All	All	3.6 LGZ	All
GMC	Canyon	2017 - 2018	All	All	3.6 LGZ	All

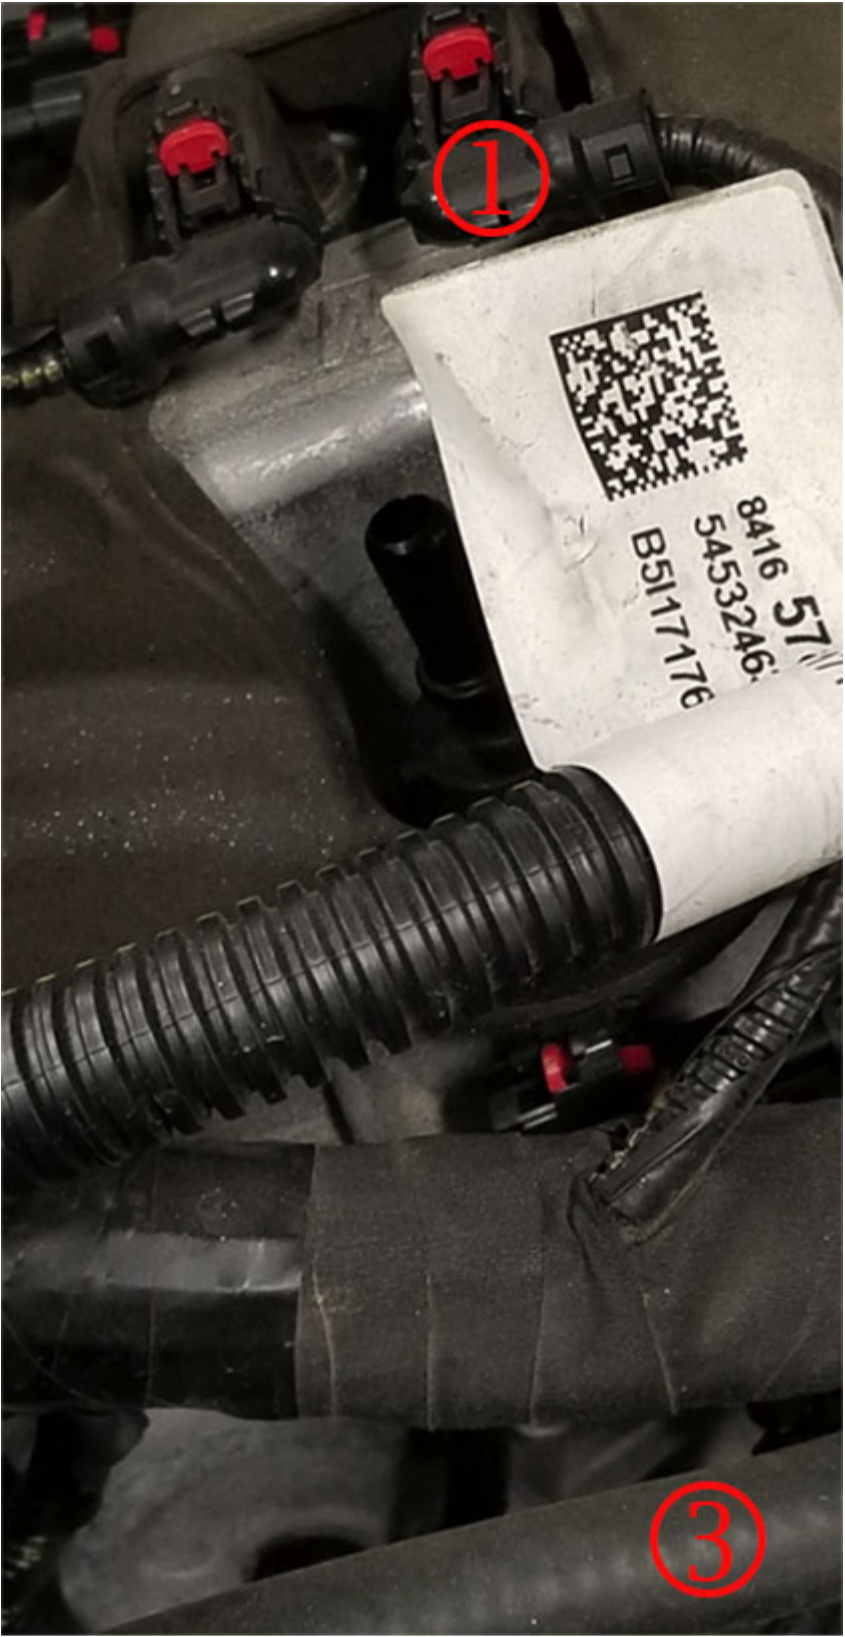
Involved Region or Country	North America
Condition	Some dealers will find a P0016 set after an engine repair that included moving the wiring harness on the right front side of the engine. This will be a hard code and will usually cause a rough idle concern.
Cause	What we are seeing is the wiring connectors for the intake camshaft actuator solenoid bank one on top of the engine and the connector for the intake actuator park lock solenoid in the front of the engine for bank one, have been swapped. These two connectors are identical and can only be identified by wire color in the connector.

- 1) Bank 1 intake actuator**
- 2) Bank 1 intake park lock solenoid
- 3) Same hose in both pictures for relativity.

**Remove the connector and look at the schematic in eSI to compare and ensure the correct connector is plugged into the actuator and lock solenoid. (See pictures below)**

If they are incorrect swap them back and clear the code to verify repair.  
If they are already in the correct places then refer to the correct eSI diagnostics for this code.
