# Preliminary Information

## PIT5620 Itch Rattle Flutter Squeak Tick Chirp Type Noise from the Drivers Side A Pillar Area

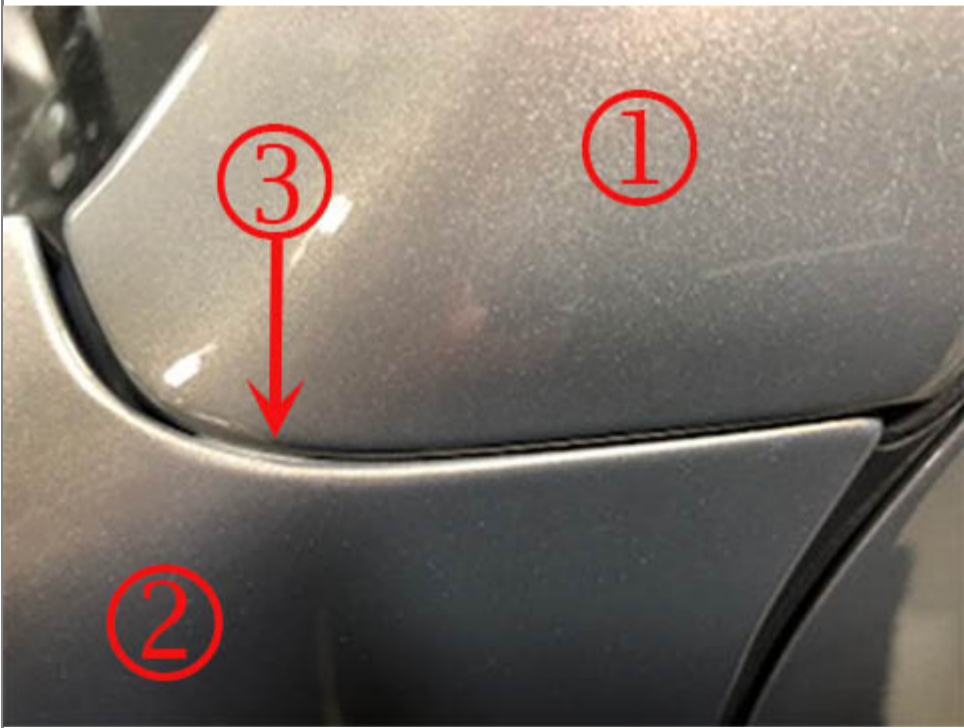
Condition	Some customers may comment of an itch, rattle, flutter, squeak, tick, and/or chirp type noise coming from the left I/P or A-pillar area. This noise may be temperature related and is heard while driving and hitting small bumps.
-----------	--

Cause	This concern could be caused by contact (3) between the left fender (2) and the bottom of the A-pillar (1), as shown below.
-------	---

To correct this concern adjust the fender. In some cases, the use of a trim tool can be used to adjust/finesse the fender flange to provide clearance to the A pillar through the door opening.
