# Preliminary Information

## PIT5622 Diagnostic Tip Side Object Detection System Unavailable Message at Startup

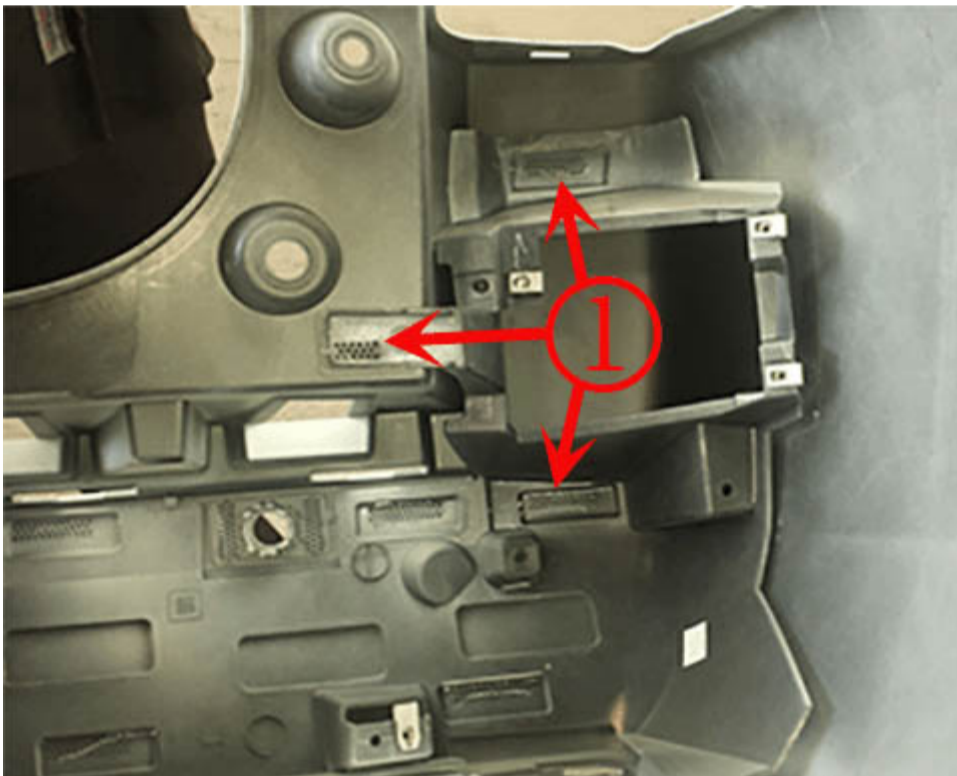
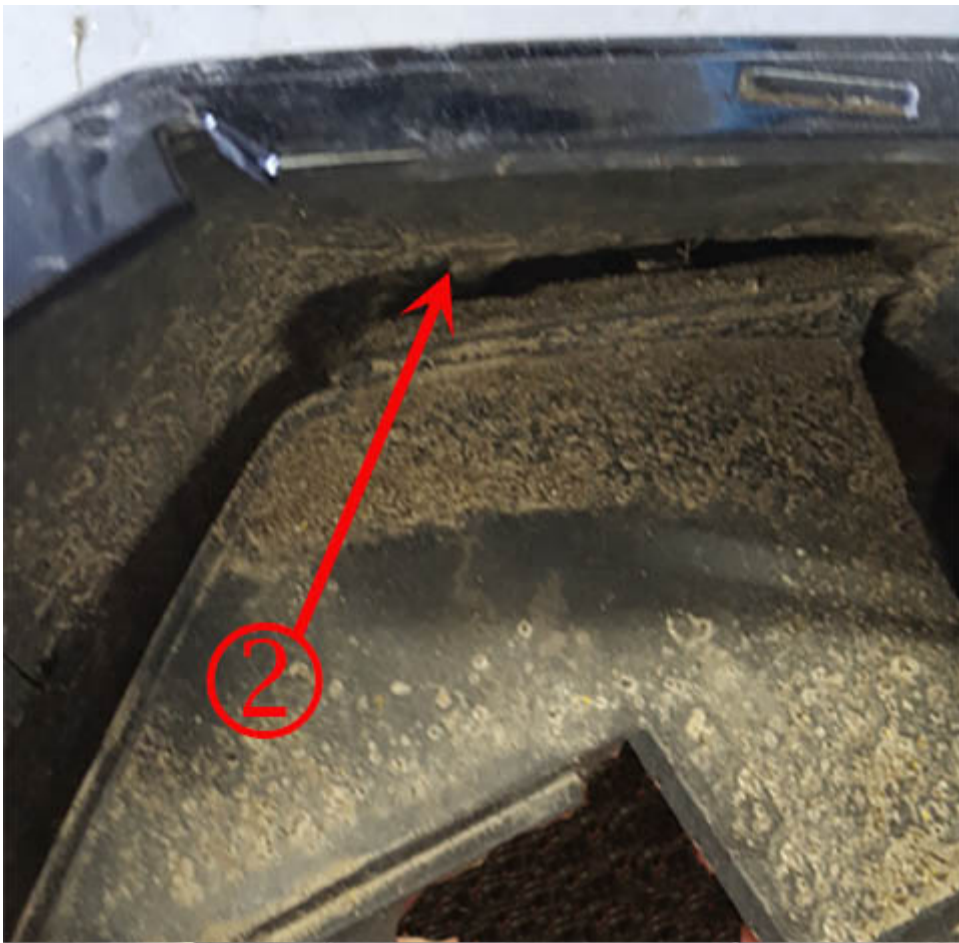
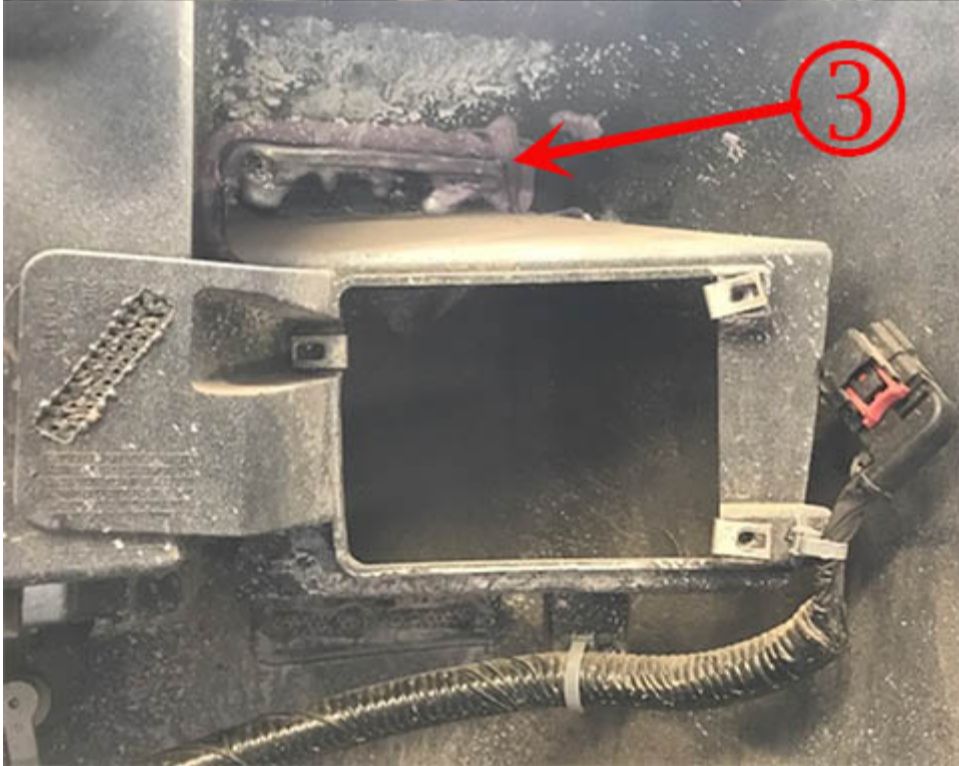
Perform a visual inspection of the Side Detection Modules, wiring, connectors and mounting brackets. The modules may need to be removed to inspect the mounting and brackets thoroughly. Look for anything broken/damaged/cracked, etc. Most importantly, inspect the heat staked areas (1) for becoming detached by lightly pulling on the bracket near the heat staked areas to make sure they are still attached. In the photo below is an example of a right hand Side Detection Module bracket, which has broken away at the top heat staked area (2). Also, inspect the brackets for being repaired or rebonded to the rear fascia (3) during a previous repair.

If any issues are found with the module mounting, mounting brackets, or rear fascia, replace as necessary.

Even after the Side Detection Module mounting issue has been repaired, the module will not immediately know that it is now mounted correctly. This will still result in a "Side Detection System Unavailable" message at start up. Because it takes time for the Side Detection Module to learn that it is now mounted correctly, the only way to immediately clear the "Side Detection System Unavailable" message at start up is to replace and program the Side Detection Module on the side that originally had the mounting issue.
