**Preliminary Information**

# PIT5457C Service ABS / TCS / Power Steering and/or Suspension Message DTC U0077 U0121 U0126 U0131 U0139 U0151 U0401 U0415 U0428 (Circuit 5986)

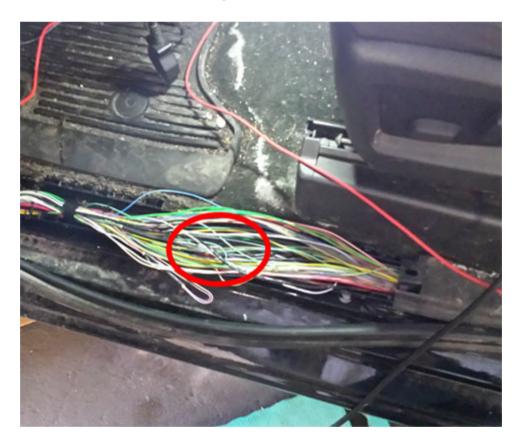
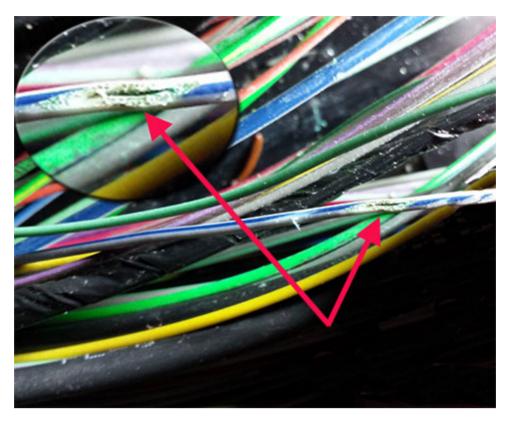
Below are three known areas where circuit 5986 has been found to be open/shorted/high resistance:

- 1. On short wheel base utilities (Escalade, Tahoe and Yukon), the chassis harness cut/pinched/shorted between the body and spare tire crossmember, see latest version of PIT5556 for more details.
- 2. Under the driver's sill plate, shown below.

no voltage is present when the concern occurs, inspect for open/high resistance/shorts on circuit 5986. Repair any opens/high resistance/shorts in the circuit.

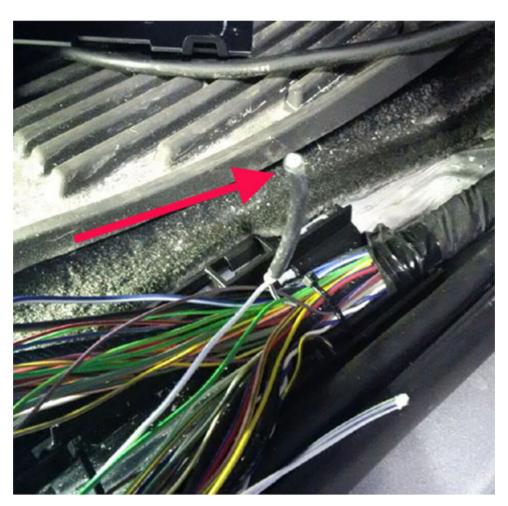
3. Splice J365 located under the passenger front sill plate, shown below.
