Preliminary Information

PIP5498K SES Lamp P050D P0300 Setting On A Cold Start And/Or a Run Rough Warm with No codes

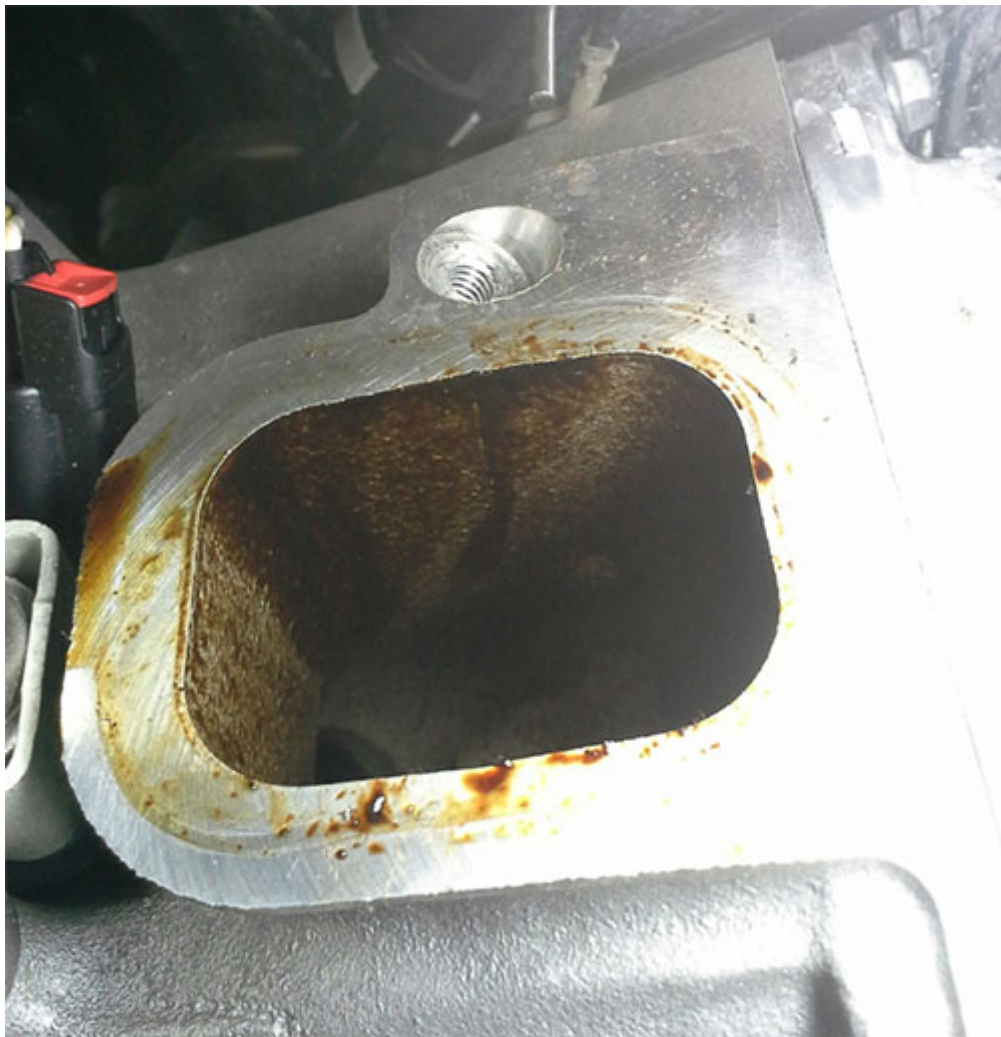
If the head casting line is the concern the intake port will be wet with a coolant oil mix.

This could be the cause of a running rough warm concern with or without codes.

The location of where the coolant is running down in the port will also look washed down.

If this is found the cylinder head will need to be replaced.

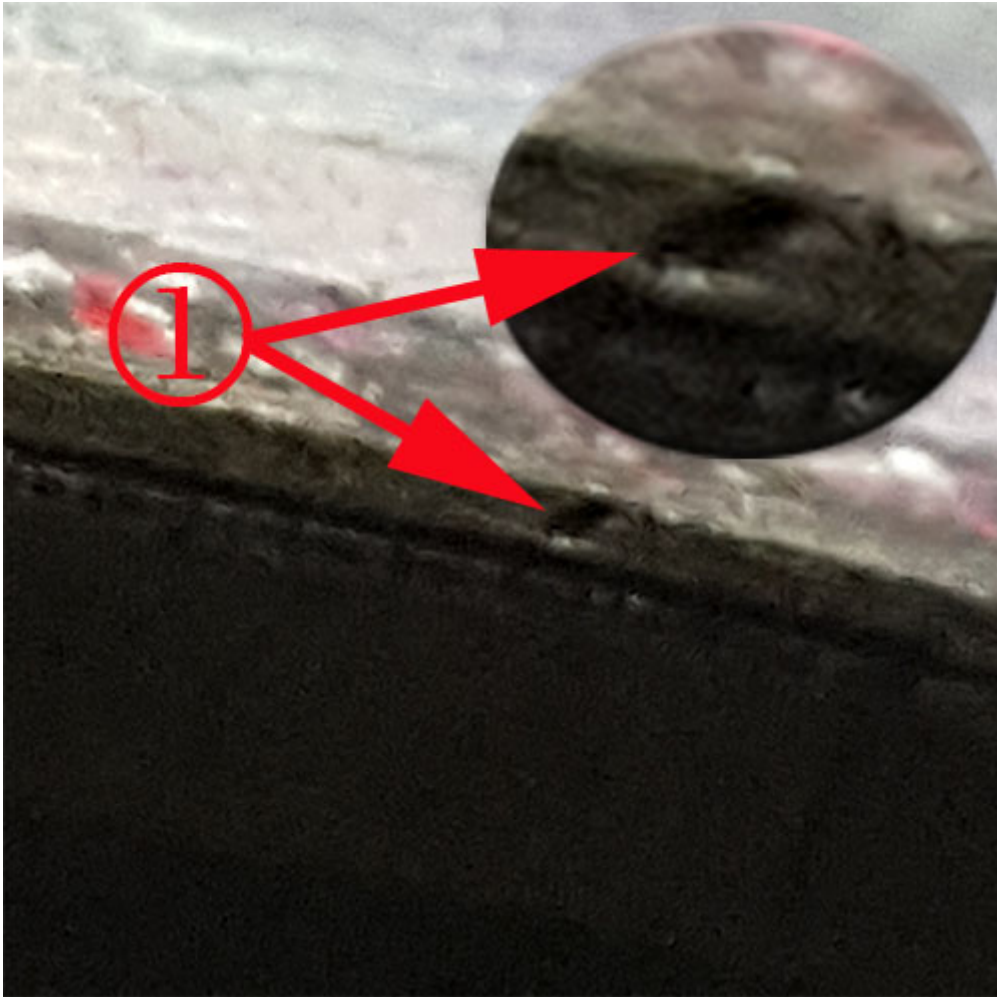
For coolant entry at the liner to deck face casting of the cylinder bore.

It is hard to see the actual source (pin hole) but it usually streams down the liner so that you can see it with a borescope.(Sometimes) The top of the piston will be steam cleaned.

Do not confuse residual fuel on the piston crown / surface as coolant. Some fuel residue may be present and can be mistaken as coolant (reason for the cooling system Dye to be added). Use black light to confirm the liquid is coolant. If this concern is present, do not replace the cylinder head because that will not repair this concern. Call PQC per the latest version of [16-NA-338](#), if required, reference this PI and replace the engine.
